Upper/Lower Windshield/Rear Glass Tick Noise

Service Category Vehicle Exterior

Section Window/Glass

If a creak, tick, or rattle noise is heard at the top or bottom of the windshield, or at the top of the rear glass, the source of the noise may be the two stoppers bonded to the top of the windshield/rear glass, or the windshield retainers bonded to the lower edge of the windshield. This bulletin provides the recommended repair procedure to eliminate these types of noises from the windshield/rear glass area.

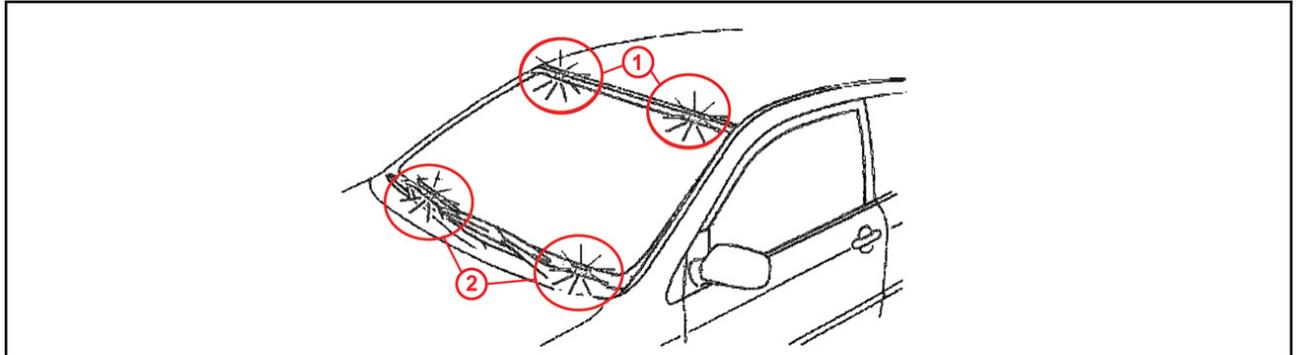
Figure 1. Retainer and Stopper Locations

1	Stopper
2	Retainer

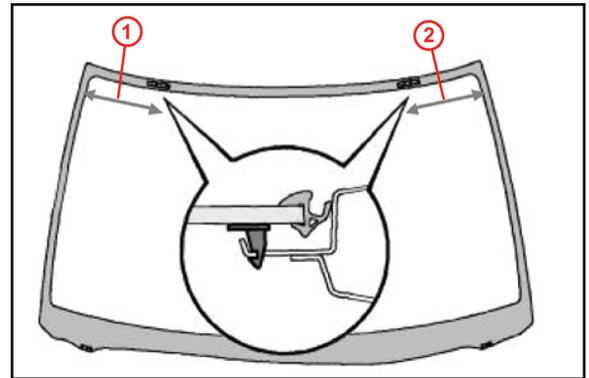
Figure 4.

The stoppers are located on the inside of the passenger compartment behind the windshield glass blackout section (near the top front edge of the metal roof opening). The stoppers are typically located 20 – 25 cm (7.9 – 9.8 in.) inboard of the top corners of the windshield glass.

1	20 – 25 cm (7.9 – 9.8 in.)
2	20 – 25 cm (7.9 – 9.8 in.)

1. Remove both sun visors and both A-pillar garnishes, and then carefully lower the front of the headliner to gain access to the windshield stoppers (refer to the appropriate model year Repair Manual for the proper procedure for removing and reinstalling the sun visors and headliner).

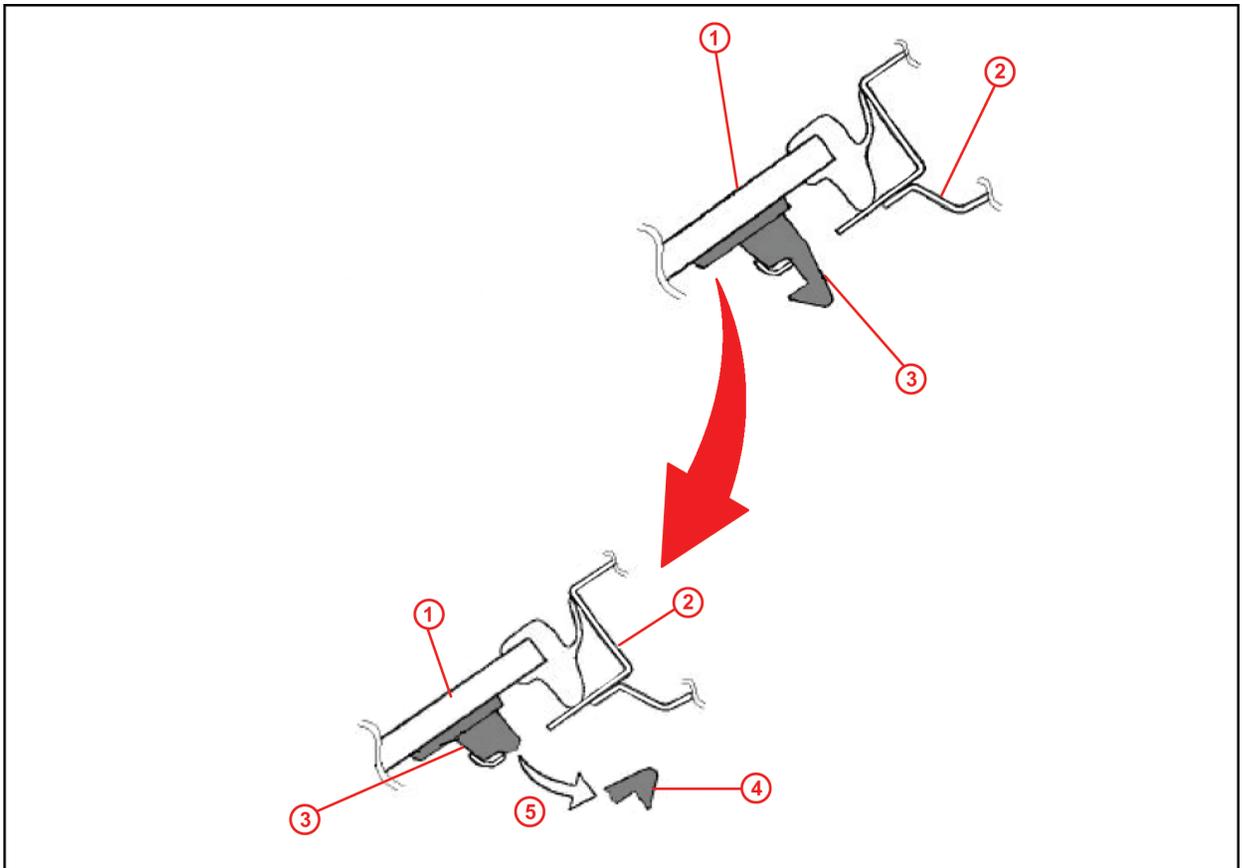
1	Windshield Glass
2	Roof Panel
3	Glass Stopper

4	Cut
5	Fragment of Glass Stopper

2. Cut OFF the tip of the plastic stopper as shown in Figure 5.

It is sometimes necessary to bend the metal body tab down to gain access to the shaft of the stopper.

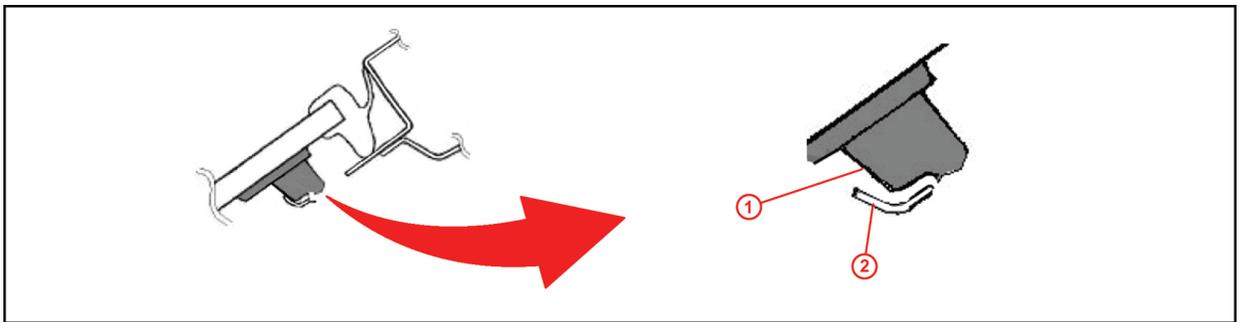
Figure 6.

1 Opening Gap

2 Roof Panel

- Once the tip of the stopper has been removed, use a screwdriver to open a gap between the roof panel and the remainder of the plastic windshield stopper.

- Test drive vehicle prior to reassembly to confirm that the noise has been eliminated.
- Reassemble the vehicle.

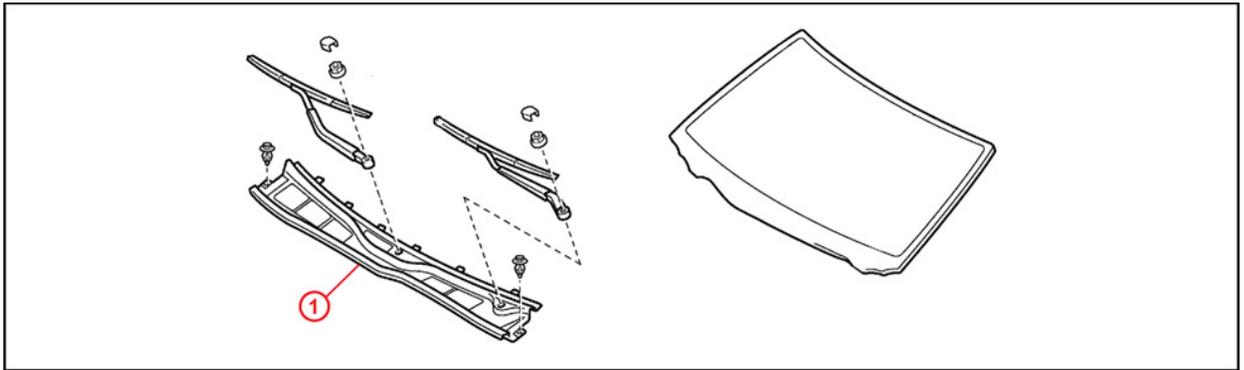
Figure 7.

1	Cowl Top Ventilator Louver
----------	-----------------------------------

1. Carefully remove the plastic cowl top ventilator louver at the base of the windshield and store it in a safe location for reinstallation later (refer to the appropriate model year Repair Manual for the proper procedure).

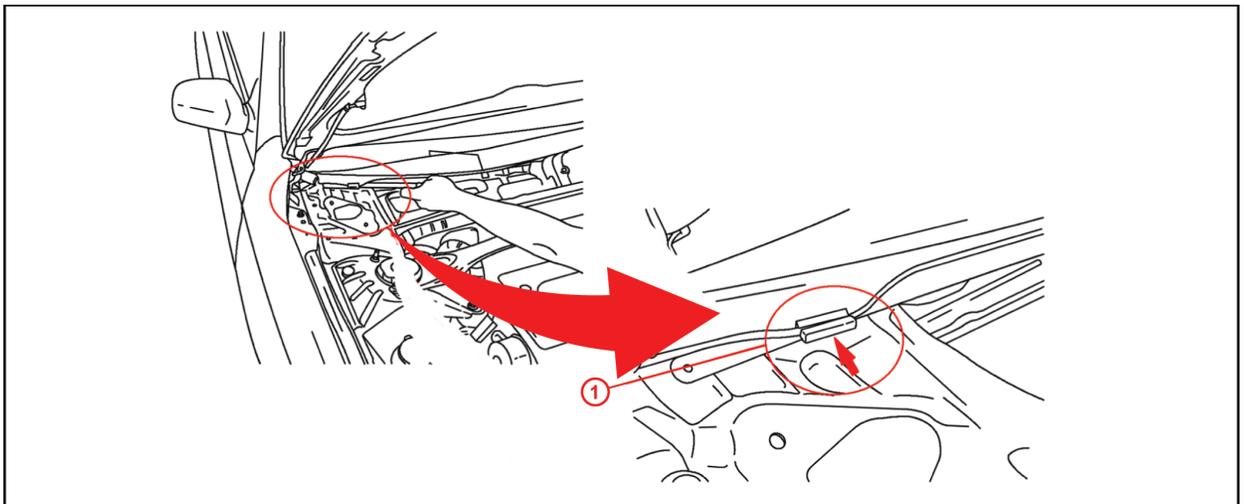
Figure 8.

The retainers are typically located 140 – 200 mm (5.5 – 7.9 in.) inboard of the lower corners of the windshield. The flat portion of the retainer is adhered to the backside of the windshield with double-sided, foam-backed tape.

1	Pin Is Attached to Plastic Block Underneath Windshield
----------	---

2. Locate the lower windshield retainers.

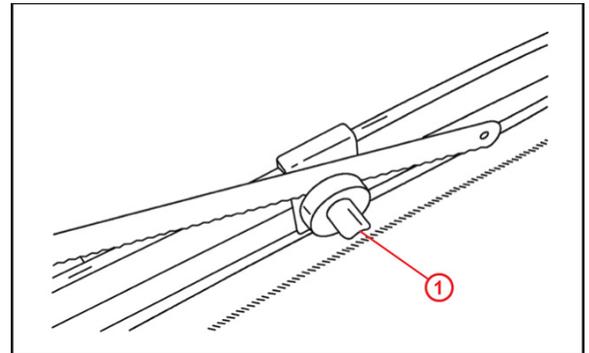
Figure 9. View from Underneath Windshield

1	Pin
----------	------------

3. Use a “mini” hacksaw with a fine tooth 10-inch blade to cut OFF the pin portion of the glass retainer flush with the flat portion of the windshield retainer as shown in Figure 9.

4. Test drive the vehicle to confirm the elimination of the noise.
5. Reinstall the cowl top ventilator louver.
