Vibration from Engine after Cold Soak

Service Category Engine/Hybrid System

Section Engine Mechanical

YEAR(S)	MODEL(S)	ADDITIONAL INFORMATION
2010 – 2011	Prius

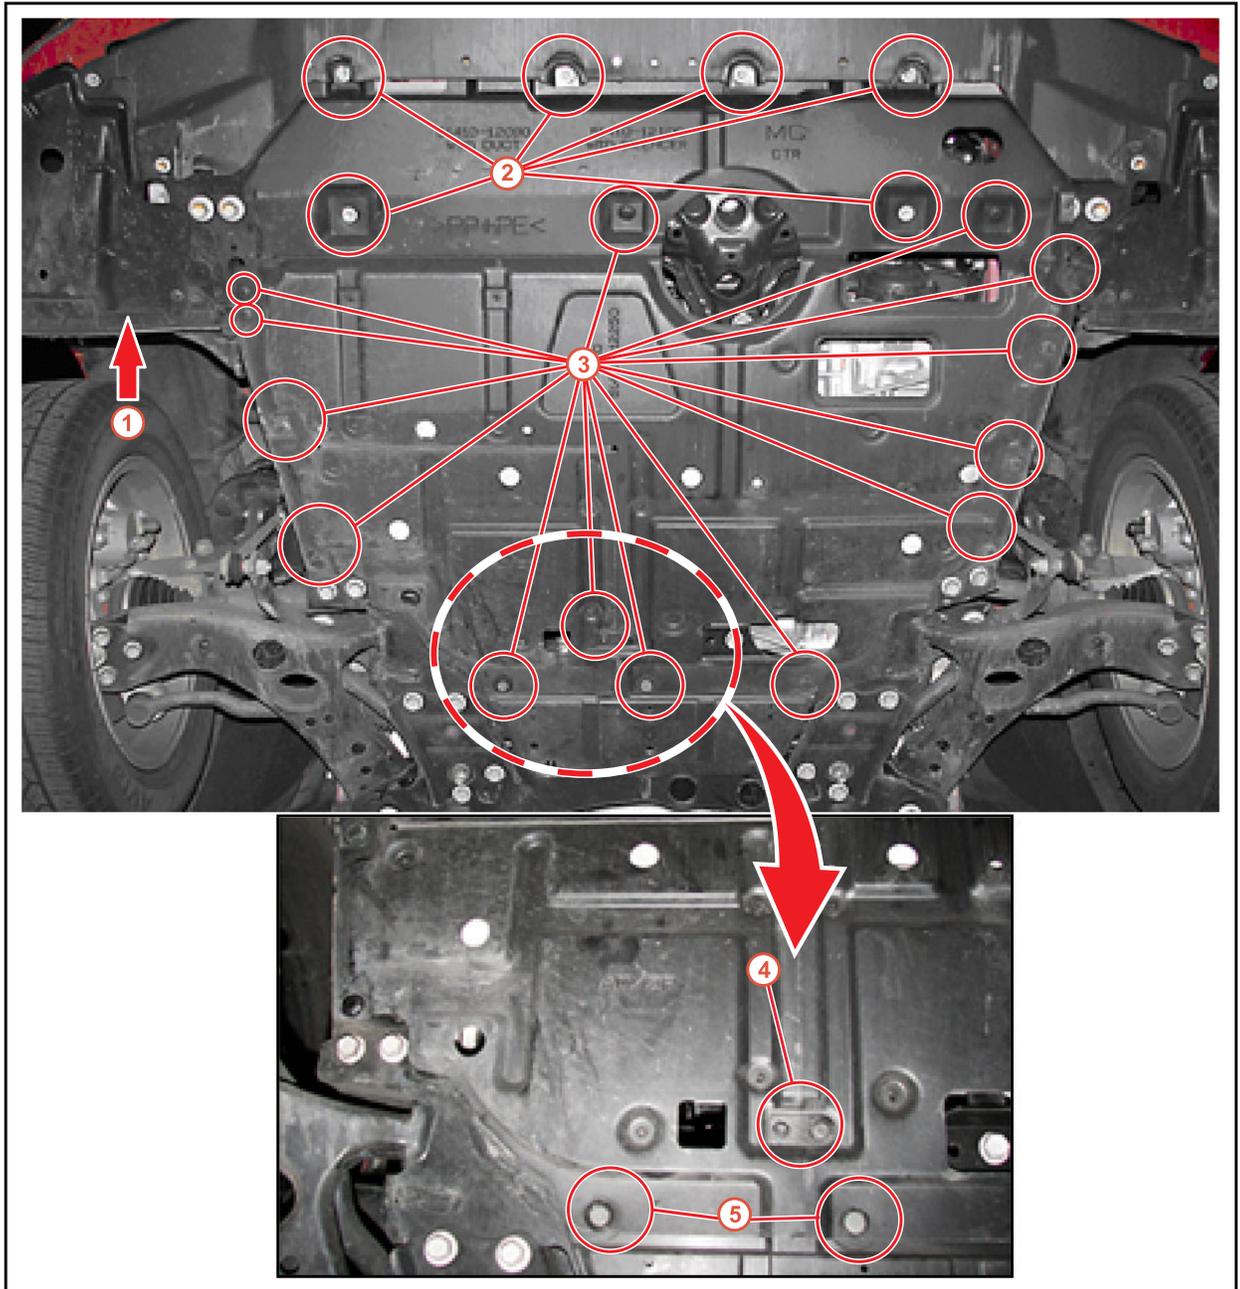
Figure 1.

Clips are not interchangeable. See Figure 1 for specific clip locations.

1	Front of Vehicle
2	Bolt
3	90467-07201: Thin Metal & Plastic Clips

4	90467-07166: Plastic & Plastic Clips
5	90467-09227: Thicker Metal & Plastic Clips

5. Reposition the engine under cover into place and install the 14 retaining clips in their correct locations, then install the 6 bolts (See Figure 1).

Gently pull down on the edges of the engine under cover to ensure the clips are installed in the correct locations.

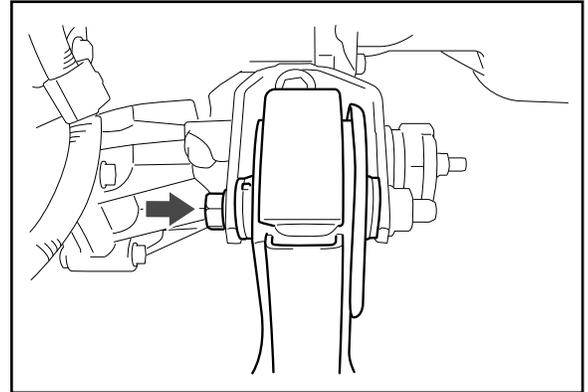
Figure 2.

Some 2010 – 2011 model year Prius vehicles may experience an abnormal vibration or droning noise with the Internal Combustion Engine (ICE) ON after extended cold soak in extremely low temperature conditions until the engine bay begins to warm up. The right rear engine mount has been updated to address this condition.

3. Properly support the engine assembly with a jack and remove the two bolts from the right rear engine mount.
4. Install the new rear engine mount and properly torque bolts.

Torque: 95 N*m (969 kgf*cm, 70 ft*lbf)
