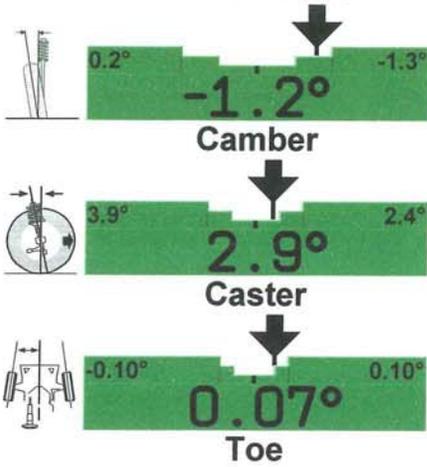
Left Front

- All angles on the front axle are within manufacturer's specifications.

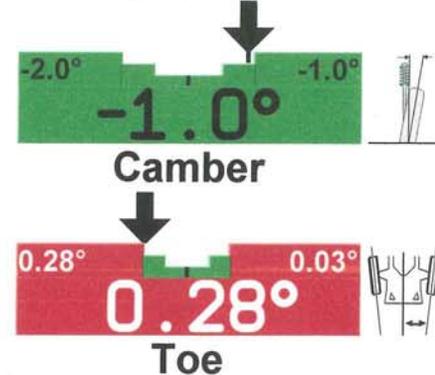
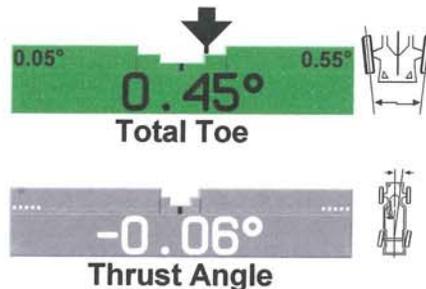
Right Rear

- Excessive Toe could cause scuffing or shoulder wear.

The right rear tire is out of specification. That will cause the steering wheel to be off by a few degrees.
