Technical Service BULLETIN

M.I.L. "ON" DTC P3130, INFORMATION CODE 346

'01 – '03 Prius

ENGINE
EG023-07

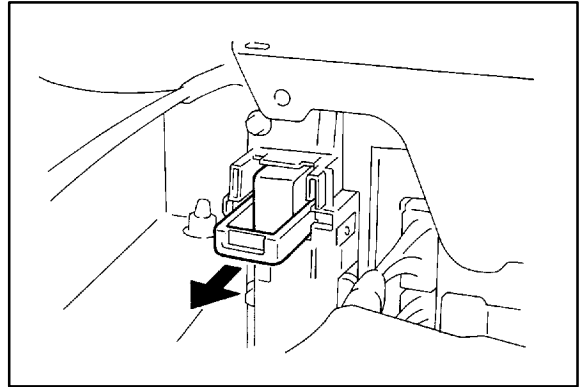
- Due to the discharge resistance, it takes at **LEAST 5 minutes** before the 273.6 V electricity is sufficiently discharged from the capacitor in the inverter circuit.
- Even after the 5 minutes have passed, the following precaution should be observed:
Before touching a 273.6 V cable or any other cable which you cannot identify, use the tester to confirm that the voltage through the cable is 12 V or less.
- After removing the service plug, cover the plug connector using rubber or vinyl electrical insulation tape.

2. After removing 273.6 V cable, be sure to cover each terminal using vinyl electrical insulation tape.
3. Do NOT leave tools or parts (bolts, nuts, etc.) inside cabin.
4. Remove pocket screwdrivers, jewelry, or other metallic objects that may fall into the work area.
