Technical Service BULLETIN

NAVIGATION, ENERGY MONITOR, CONSUMPTION, & CASSETTE EJECT MALFUNCTION

'01 – '02 Prius

ELECTRICAL
EL013-00
REVISED

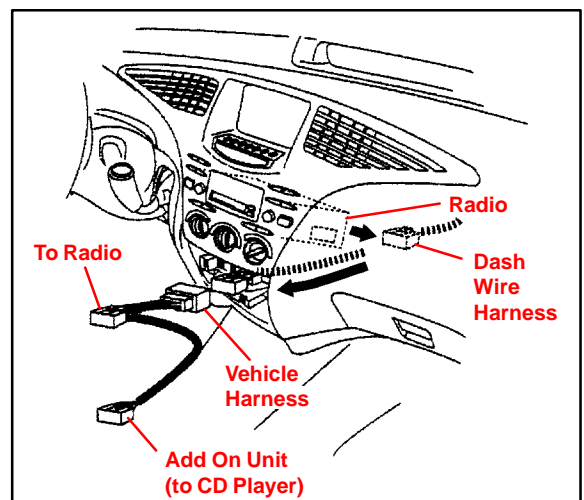
One harness connector is connected to the CD player and the other is connected to the dash wire harness.

4. Disconnect the 2 male Y-adapter harness connectors.
