# Memorandum

Subject: REPORT: Vehicle and Crash Site Inspection of 2009  
Lexus ES-350, VIN JTHBJ46G792282025

Date of Inspection: 09/03/2009

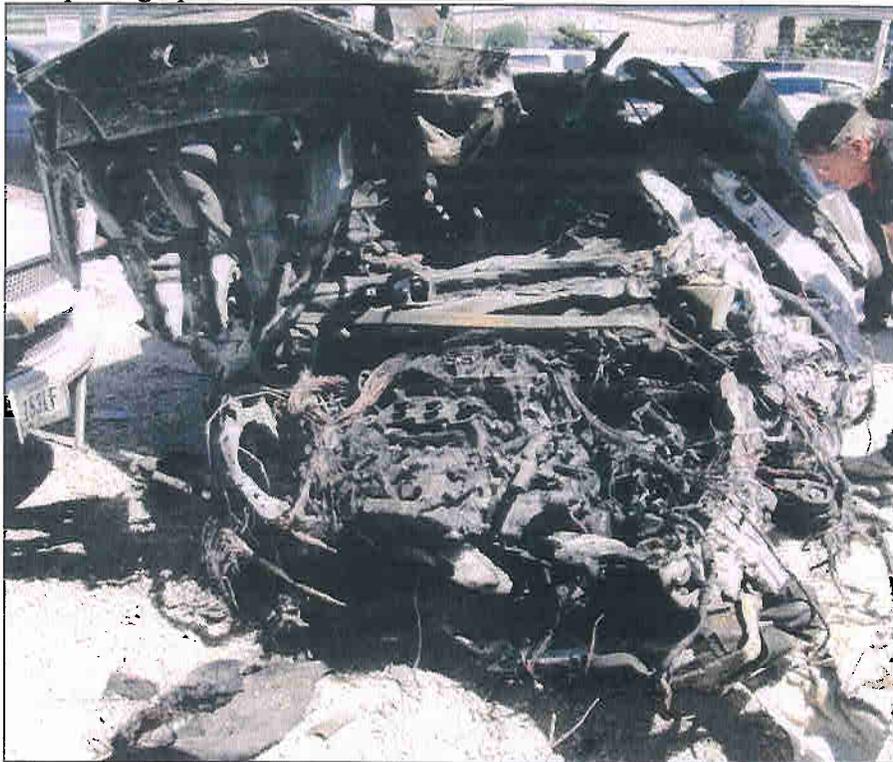
Vehicle condition at time of inspection: Catastrophic damage caused by severe frontal impact, roof impact, side impact, & fire damage. The driver's seat buckle was observed in a closed, connected condition.

**Figure 1 - Subject Vehicle 2009 Lexus ES-350 – Front**

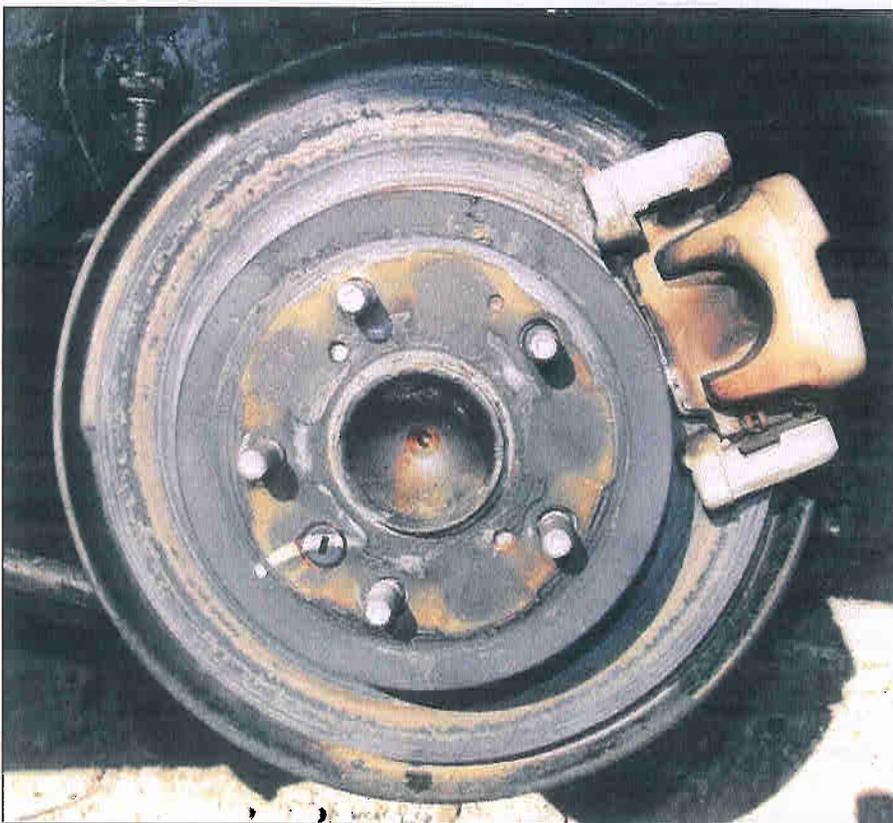
- 4- The brake pads and rotors were inspected for heat generated by emergency braking. While there was significant fire damage to the majority of the vehicle, the pads, rotors, and calipers could still be observed. The left front wheel assembly and suspension were torn from the vehicle in the crash and had not been involved in the fire. Other rotors on the vehicle generally exhibited similar conditions. Rotors were discolored and heated, had very rough surfaces, had substantial deposits of brake pad material, and showed signs of bright orange oxidation on the cooling fins consistent with endured braking. Pads were melted and rough with a considerable amount surface material dislocated to the leading edge. The friction surfaces were burned but somewhat reflective. The edges of the pads were bubbled. The calipers were also heat discolored with heat patterns in the area adjacent to the rotor.

**Figure 2 - Rear Left Caliper and Rotor Exhibiting Signs of Endured Braking**

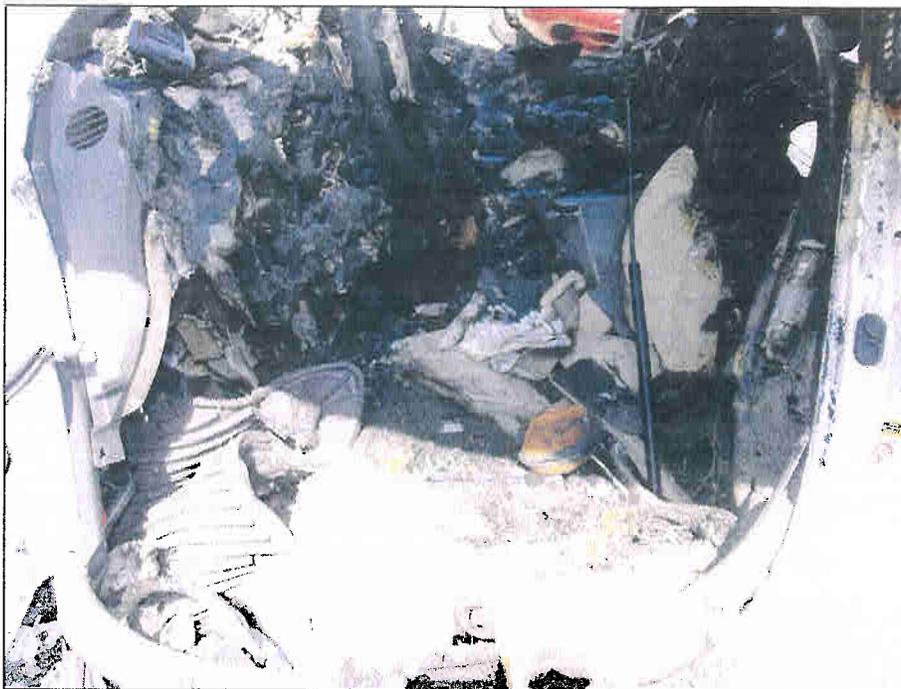
- 2- Upon inspection of the crashed vehicle, it was found that an all-weather floor mat bearing the Lexus insignia was present in the driver's foot well vehicle with very minor fire damage. The mat was not secured by either of the two retaining clips. The right clip was installed into the grommet of the carpeting but not installed into the mat. The left clip was found under the middle of mat but was not clipped to either the carpet or the rubber mat. Removal of the mat was difficult because the bottom edge of the accelerator pedal had melted to the upper right corner of the mat. Further inspection of the mat revealed that while it was a Lexus brand mat, it was not the correct application for the vehicle. The mat part number was stamped and still visible on the reverse side. It read "PT 48050

PT908 – 48060 Front Driver >TPF< 170”. When referenced, this part number indicates that it is used in a 2005-2009 Lexus RX400H sport utility vehicle.

**Figure 3 - Driver's Compartment with Lexus All Weather Floor Mat**

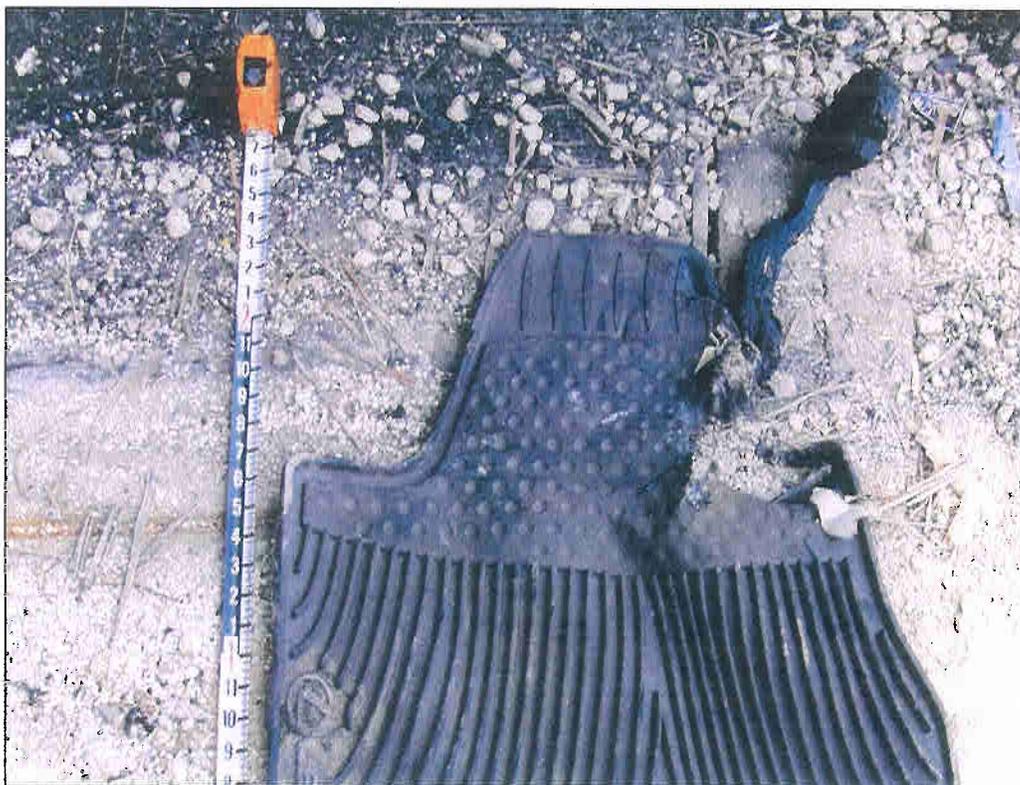
- 1- Accelerator Pedal – The pedal is made from a composite plastic that forms a rigid, one-piece lever. Beyond the main pivot, the lever is not hinged and has no means for relieving forces caused by interferences. Upon removing the pedal from the vehicle, the rotating motion of the pedal assembly was confirmed to still be operational. The return spring action was smooth and unencumbered.

**Figure 4 - All Weather Floor Mat Removed from Driver's Footwell, Bonded to Lower Edge of Accelerator Pedal Assembly**
