REPAIR MANUAL SUPPLEMENT: VEHICLE PULLING TO ONE SIDE

All '02 – '07 Toyota & '04 – '07 Scion Models

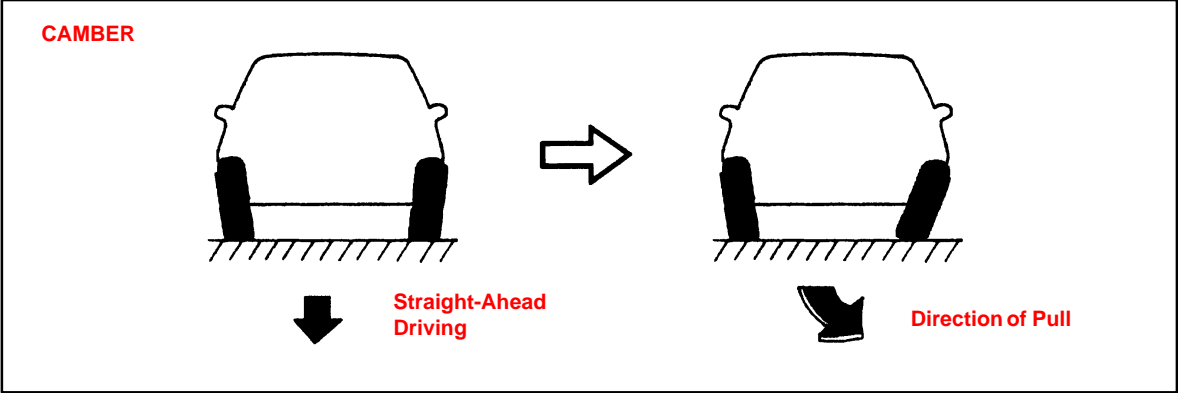
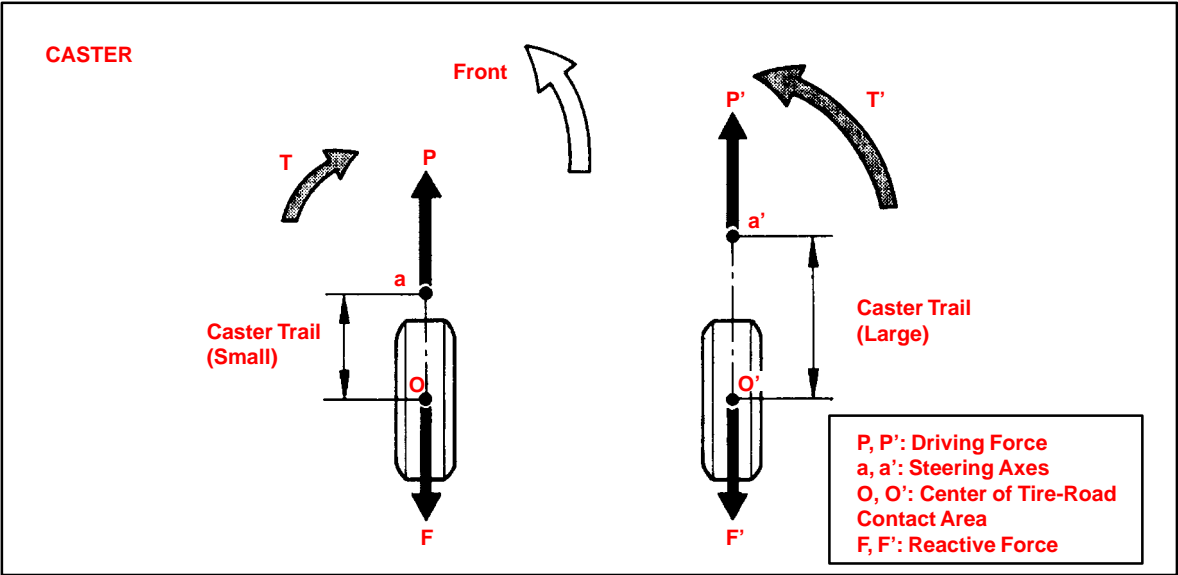
1. Relationship Between Wheel Alignment and Vehicle Pulling to One Side
- When the cross camber or caster of the front wheel alignment is large, it can cause vehicle pulling.

WHEEL ALIGNMENT	DIRECTION OF VEHICLE PULLING
Camber	Vehicle pulls in direction of wheel with large camber value
Caster	Vehicle pulls in direction of wheel with small caster value

If the cross camber or caster is within the specified range (30' or less), noticeable vehicle pulling will not occur due to side-to-side differences in camber or caster.

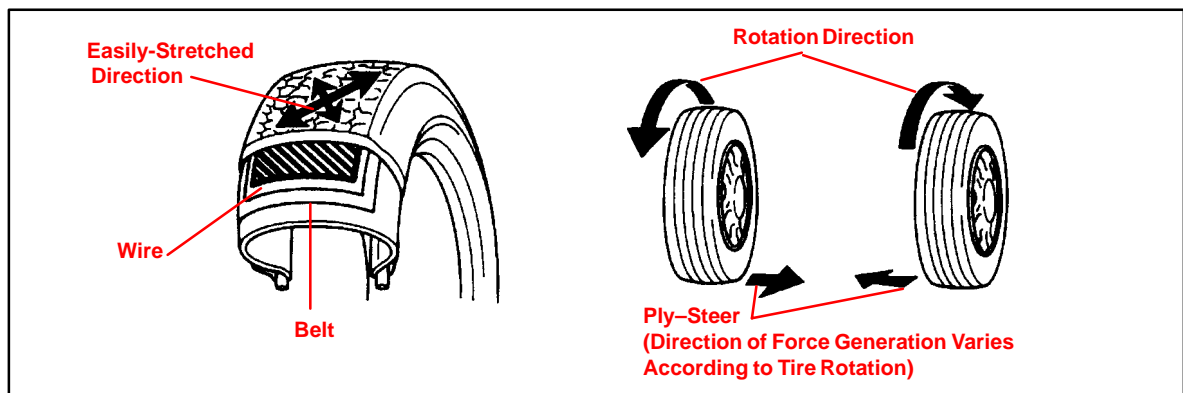
A. Ply-Steer

Lateral force due to ply-steer is produced by the construction of the belts inside the tire tread. With radial tires, the wire of the belt is slanted as shown in the illustration below. Thus, it is in the lateral direction that tire tread easily changes shape (stretches), and lateral force is generated between the tire and the road surface in the lateral direction.

Lateral force from ply-steer prevents vehicle drift caused by road slant, so in many cases lateral force to the left is provided to compensate for road slant to the right.

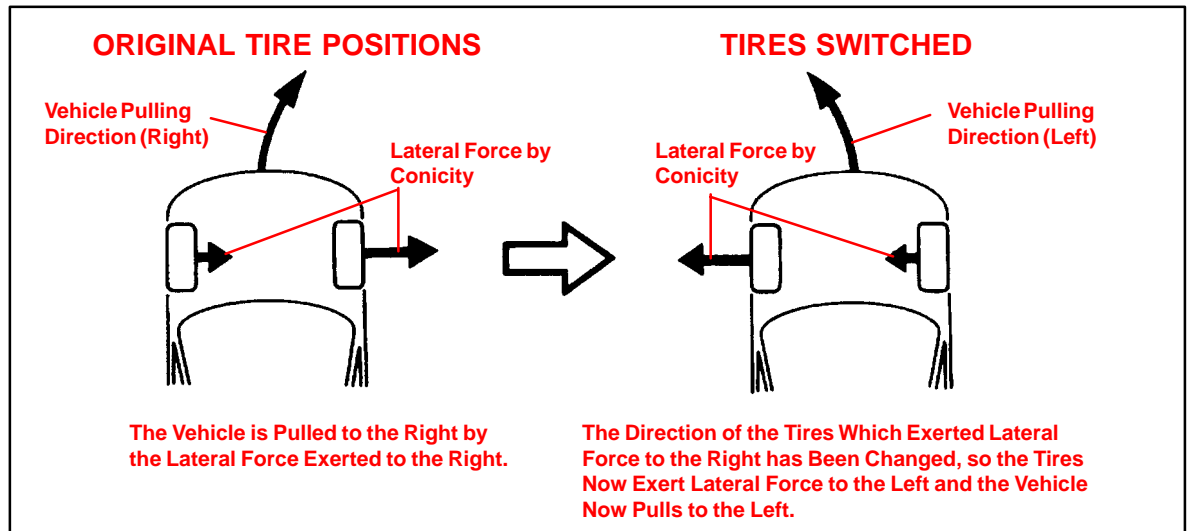
- The direction of lateral force from tire conicity becomes reversed when the left and right tires are switched. Therefore, if the pulling direction changes when the tires are switched, it can be concluded that vehicle pulling is caused by tire conicity.

- If the pulling direction does not change after the front tires are switched, the cause of vehicle pulling is not tire conicity. In this case, the likely cause is a front wheel alignment condition.

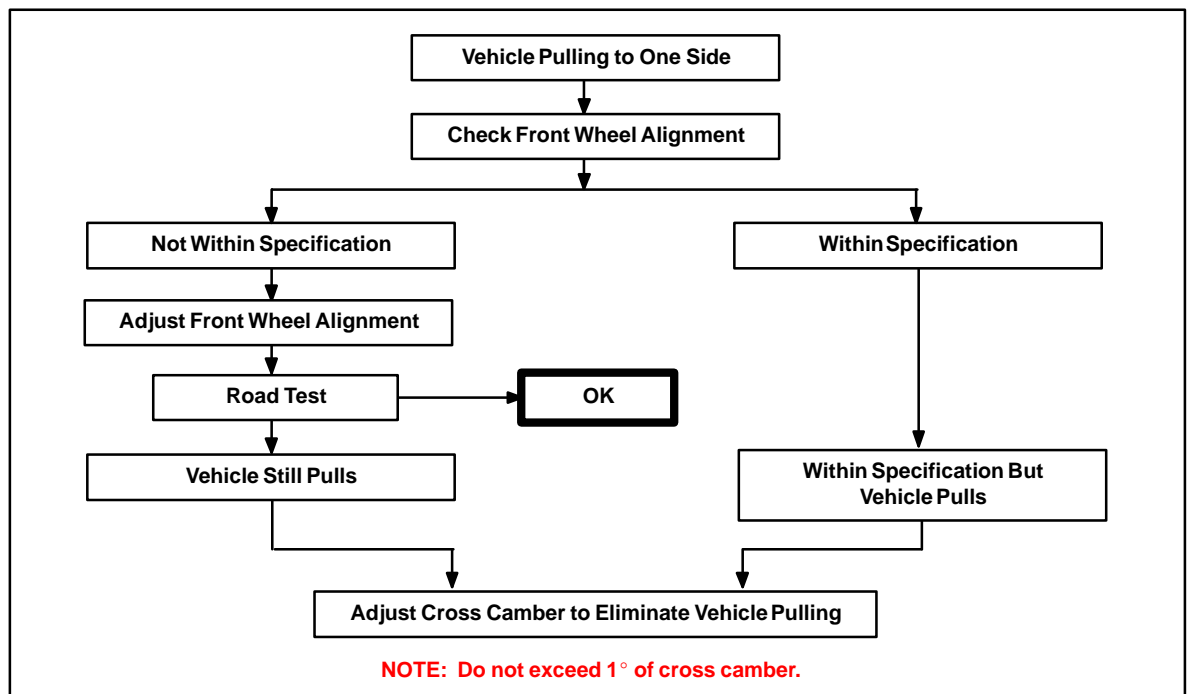
3. Vehicle Pulling Caused by Wheel Alignment

When it is determined by troubleshooting that the vehicle pulling to one side is caused by wheel alignment, perform repairs according to the following procedure.

WHEN VEHICLE PULLS TO LEFT	WHEN VEHICLE PULLS TO RIGHT
Increase right front camber and decrease left front camber until vehicle pulling is eliminated	Increase left front camber and decrease right front camber until vehicle pulling is eliminated

- NOTE:**
- Keep the cross camber within 1° or less.
 - Keep the camber of each wheel within specifications (+/-45' of center value).
 - If adjustment exceeds the specifications, uneven tire wear will result.

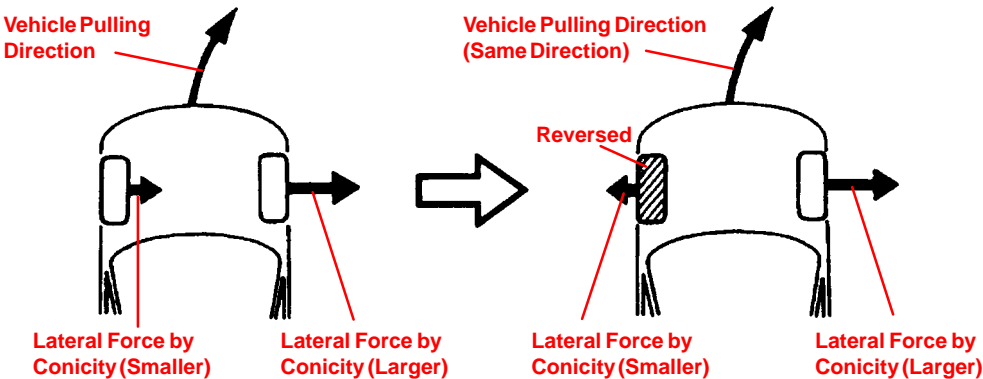
ORIGINAL TIRE POSITIONS LEFT TIRE REVERSE INSTALLATION

If Vehicle Pulls in the Same Direction: Go to STEP 2.
The lateral force generated by the right front tire is greater than the left tire, so the vehicle is pulling due to the lateral force of the right tire.

STEP 1:
Remove the front left tire from the wheel and reverse the tire. Then perform a road test and check for change in the pulling direction.

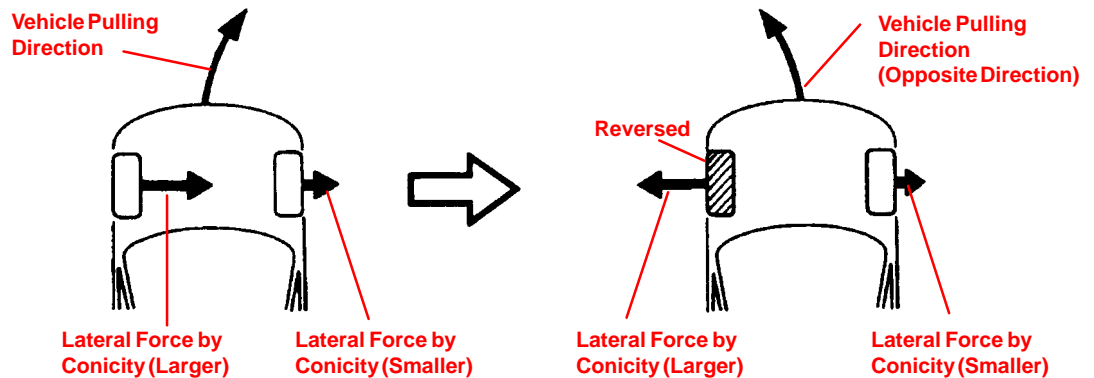
If Vehicle Pulls in the Opposite Direction: Go to STEP 2.

The lateral force generated by the left front tire is greater than the right tire, so the vehicle is pulling due to the lateral force of the left tire.

Rotate the **larger** lateral force front tire with the rear tire and check the change in the vehicle pulling.
