II. IDENTIFICATION OF AFFECTED VEHICLES

IV. BACKGROUND AND COMPONENTS

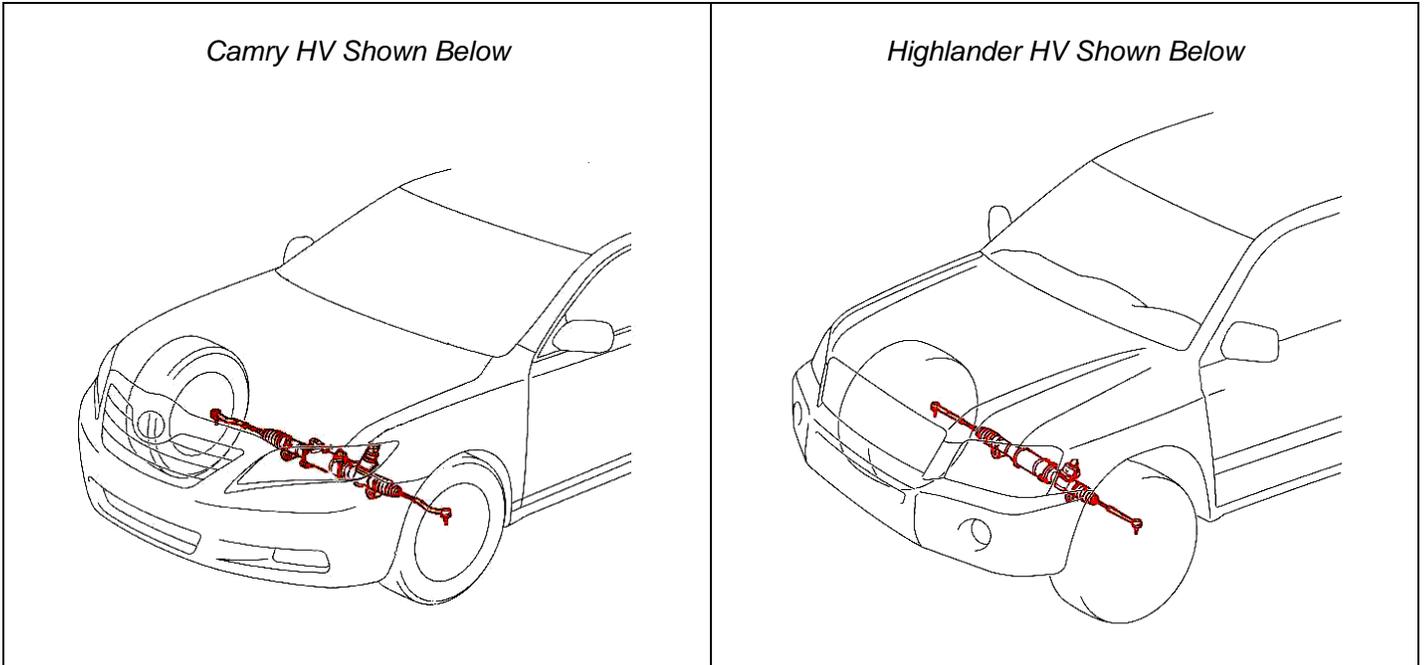
In certain '06 – '07 MY Highlander HV and '07 MY Camry HV, due to insufficient adhesion between the permanent magnets and the rotor of the EPS, the motor may gradually lose torque when the wheel is turned to the complete left or right position. If this condition occurs, customers may experience a noticeable gradual increase in the steering effort necessary at low speeds. This condition may be most perceptible when parking the vehicle.

THIS TI CONTAINS REPLACEMENT OF THE EPS ASSEMBLY FOR BOTH THE CAMRY HV AND THE HIGHLANDER HV. REFER TO THE FOLLOWING PAGES FOR VEHICLE SPECIFIC PROCEDURES:

- CLEAR THE ROTATION ANGLE SENSOR CALIBRATION VALUE.
- INITIALIZE THE ROTATION ANGLE SENSOR.
- CALIBRATE THE TORQUE SENSOR TO THE ZERO POINT.
- INITIALIZE THE SFI SYSTEM.
