IG1 Relay Freezing

Service Category Power Source/Network

Section Networking

Market USA

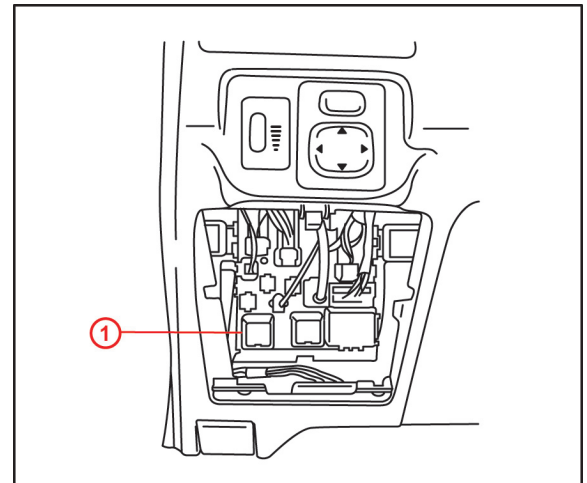
Figure 1.

1. Locate the instrument panel junction block No. 1 in the Instrument Panel (as shown in Figure 1).
2. Remove the relay and verify the part number located on the side of the relay.
 - A. If the part number is NOT 90987-02031, then replace the relay with the countermeasure relay.
 - B. If the part number is 90987-02031, then diagnose the specific conditions reported by the customer following the Repair Manual.

1 IG1 Relay
