# Headlamp Condensation

YEAR(S)	MODEL(S)	ADDITIONAL INFORMATION
2007 – 2009	Prius

Some 2007-2009 model year Prius vehicles may have an appearance issue and exhibit excessive condensation or moisture on the interior of the headlamp(s). Follow the procedures in this bulletin to address this condition.

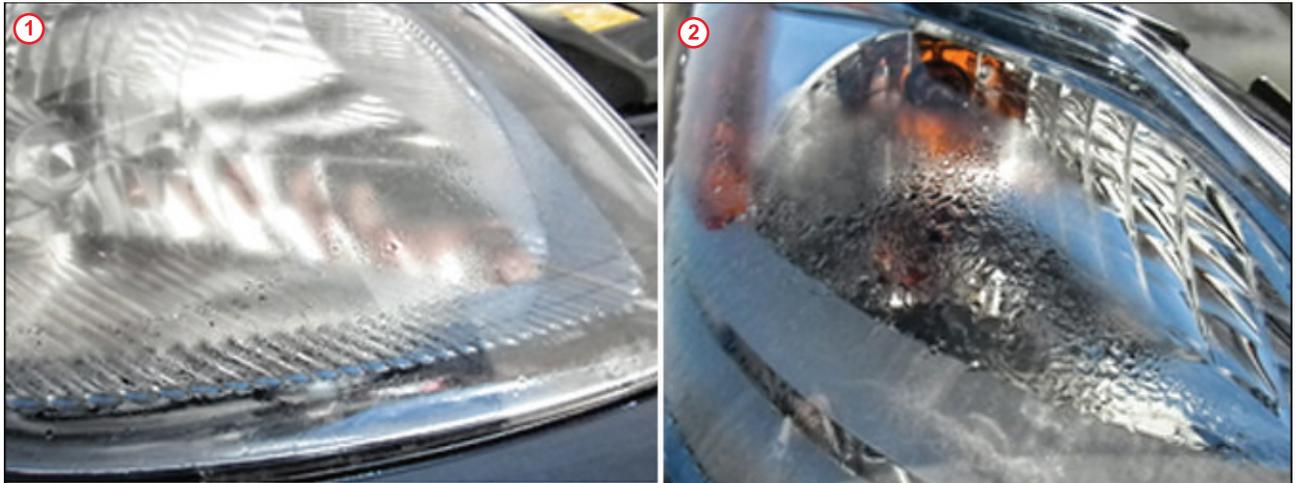
**Figure 1.**

1. Confirm buildup of excessive condensation or moisture in headlamp assembly(s).

<b>1</b>	<b>Excessive condensation</b>
----------	-------------------------------

<b>2</b>	<b>Moisture</b>
----------	-----------------

If headlamps have excessive condensation or moisture present, proceed with repair. If condensation or moisture is not present this TSB does NOT apply.

2. Replace the affected headlamp assembly(s).
