Vibration from Engine after Cold Soak

Service Category Engine/Hybrid System

Section Engine Mechanical

YEAR(S)	MODEL(S)	ADDITIONAL INFORMATION
2010 – 2011	Prius

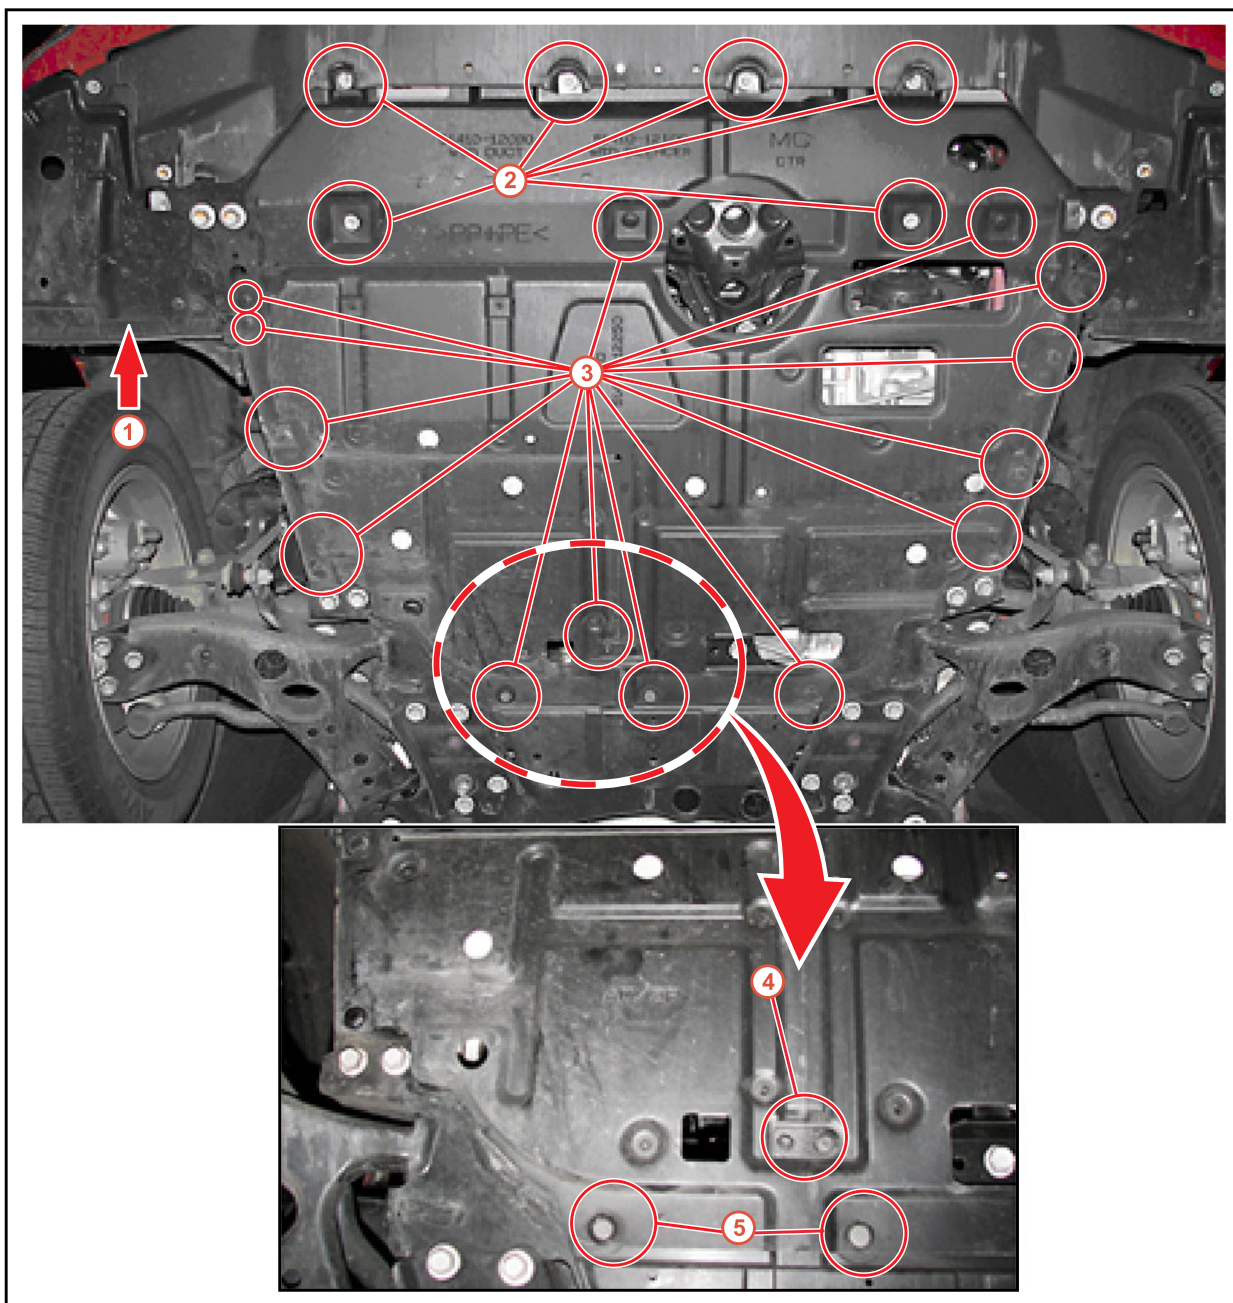
Figure 1.

Clips are not interchangeable. See Figure 1 for specific clip locations.

Remove the 6 bolts and 14 retaining clips from the engine under cover and slide toward rear of vehicle to remove cover.

5. Reposition the engine under cover into place and install the 14 retaining clips in their correct locations, then install the 6 bolts (See Figure 1).
