Abnormal Metallic Knock Noise from Front of Vehicle

Service Category Drivetrain

Section Hybrid Transmission/Transaxle

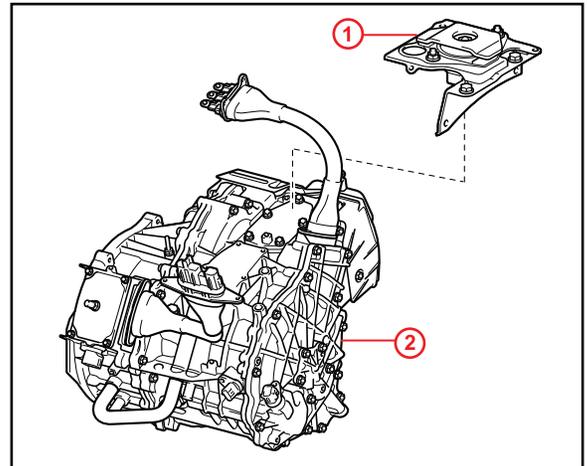
Figure 1.

1	No. 3 Engine Mounting Bracket
2	Hybrid Vehicle Transaxle Assembly

2. Support the hybrid transaxle assembly by using a transmission jack.
3. Remove and replace the engine mounting insulator LH.
 - A. Remove the engine mounting insulator sub-assembly LH from the vehicle.

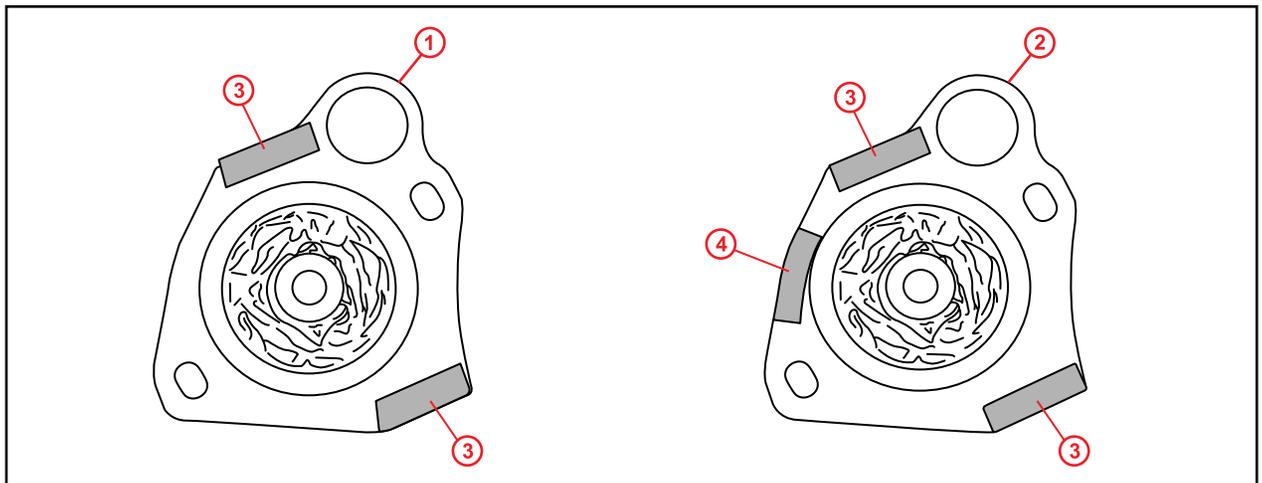
Figure 3.

1	Old Part (Before Countermeasure)
2	NEW Part (After Countermeasure)

3	EPT Sealer (10 x 35 mm [0.39 x 1.38 in.])
4	Added EPT Sealer (10 x 35 mm [0.39 x 1.38 in.])

- C. Replace the engine mounting insulator LH with the NEW part (P/N 12372-21111).

- D. Tighten the 2 nuts.
Torque: 64 N*m (640 kgf*cm, 47 ft*lbf)
- E. Attach the engine mounting insulator sub-assembly LH on the vehicle.
Torque: 80 N*m (800 kgf*cm, 59 ft*lbf)
