## Technical Service BULLETIN

### REPAIR MANUAL SUPPLEMENT: VEHICLE PULLING TO ONE SIDE

'08 Toyota

SUSPENSION  
SU001-08

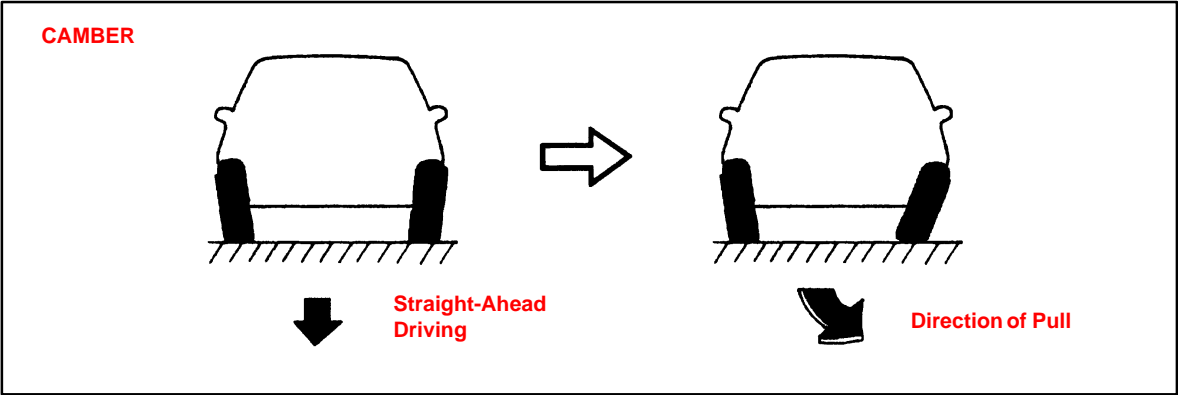
1. Relationship Between Wheel Alignment and Vehicle Pulling
- When the cross camber or caster of the front wheel alignment is large, it can cause vehicle pulling.

WHEEL ALIGNMENT	DIRECTION OF VEHICLE PULLING
Camber	Vehicle pulls in direction of wheel with large camber value
Caster	Vehicle pulls in direction of wheel with small caster value

If the cross camber or caster is within the specified range (30' or less), noticeable vehicle pulling will not occur due to side-to-side differences in camber or caster.

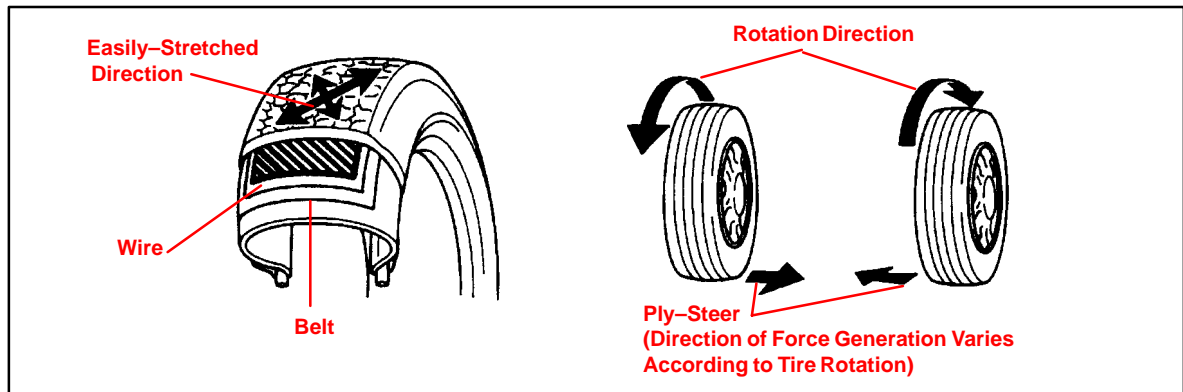
Lateral force due to ply-steer is produced by the construction of the belts inside the tire tread. With radial tires, the wire of the belt is slanted as shown in the illustration below. Thus, it is in this direction that tire tread easily changes shape (stretches), and lateral force is generated between the tire and the road surface.

Lateral force from ply-steer prevents vehicle drift caused by road slant, so in many cases lateral force to the left is provided to prevent or minimize vehicle drift.

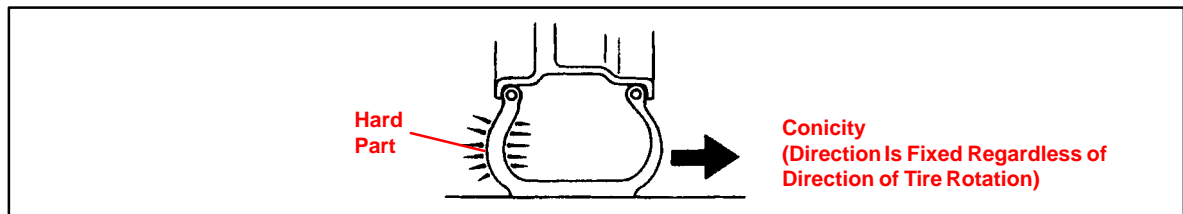
Conicity is lateral force resulting from uneven formation of the left and right sides of the tire. The direction the lateral force is exerted depends on the hardness of the side walls and the difference in height between the left/right sides of the tire.

- In the case of vehicle pulling caused by tires, the lateral force which is exerted as a result of conicity has the greatest effect. On a flat road, if the steering wheel is held without exerting steering effort for 109 yards (100 m) when travelling at 62 mph (100 km/h), the vehicle may drift as much as 5 ft (1.5 m).
- When vehicle pulling is due to conicity, the amount of drift can be reduced and the direction of drift can be changed by changing the location of the tire or reversing the tire when installing it on the wheel.

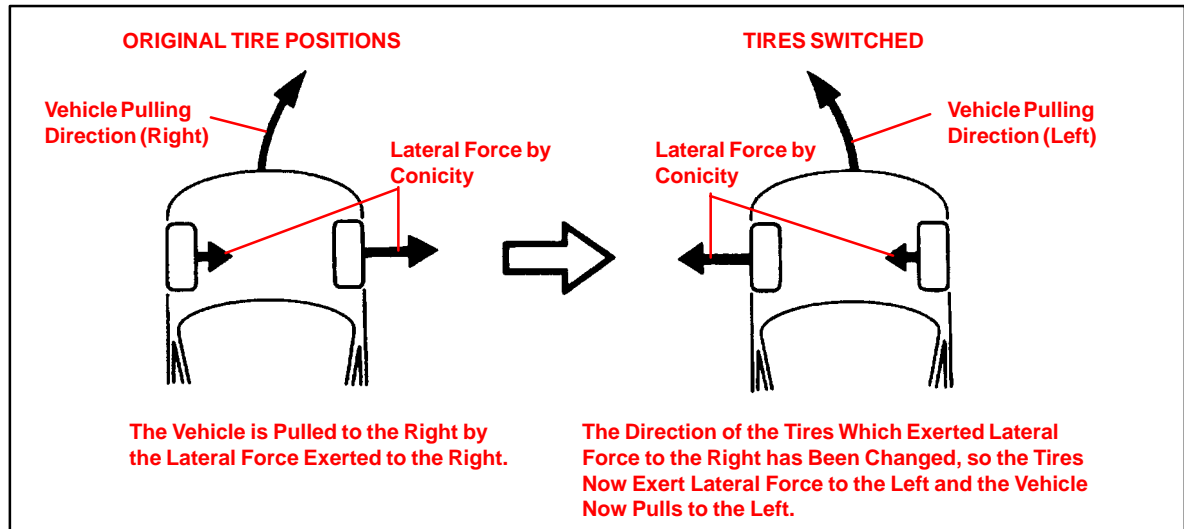
- The direction of lateral force from tire conicity becomes reversed when the left and right tires are switched. Therefore, if the pulling direction changes when the tires are switched, it can be concluded that vehicle pulling is caused by tire conicity.

- If the pulling direction does not change after the front tires are switched, the cause of vehicle pulling is not tire conicity. In this case, the likely cause is a front wheel alignment condition.

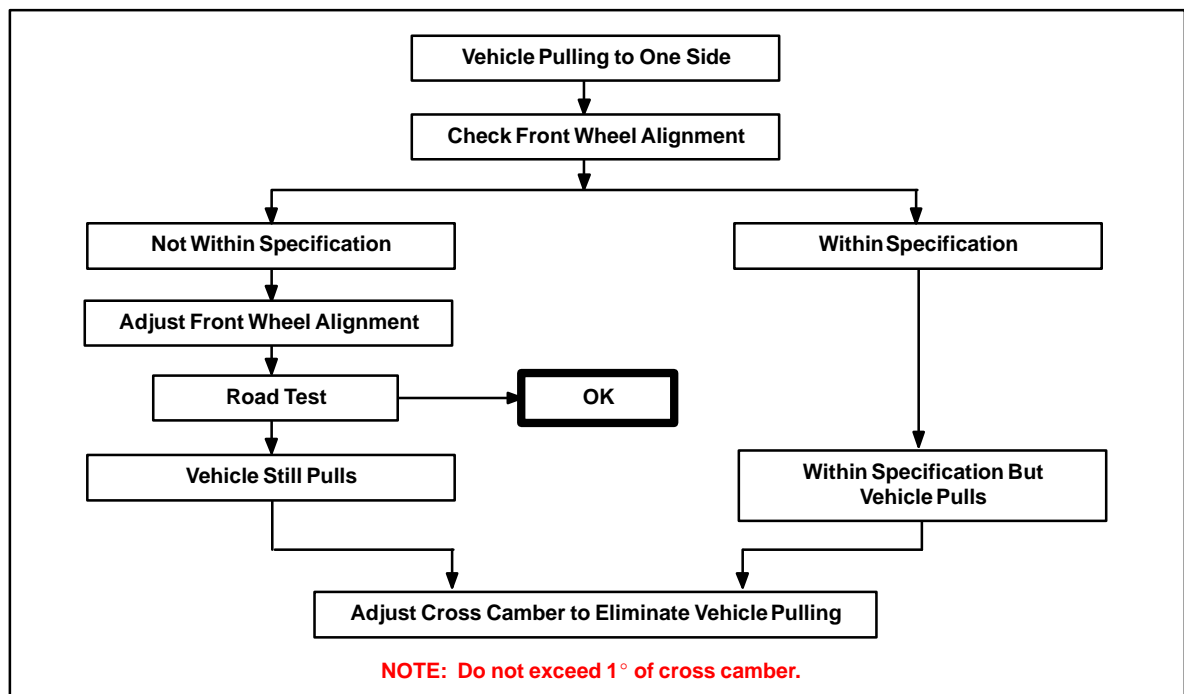
When it is determined by troubleshooting that the vehicle pulling is caused by wheel alignment, perform repairs according to the following procedure.

WHEN VEHICLE PULLS TO LEFT	WHEN VEHICLE PULLS TO RIGHT
Increase right front camber and decrease left front camber until vehicle pulling is eliminated	Increase left front camber and decrease right front camber until vehicle pulling is eliminated

- Keep the cross camber within 1° or less.
- Keep the camber of each wheel within specifications (+/-45' of center value).
- If adjustment exceeds the specifications, uneven tire wear will result.

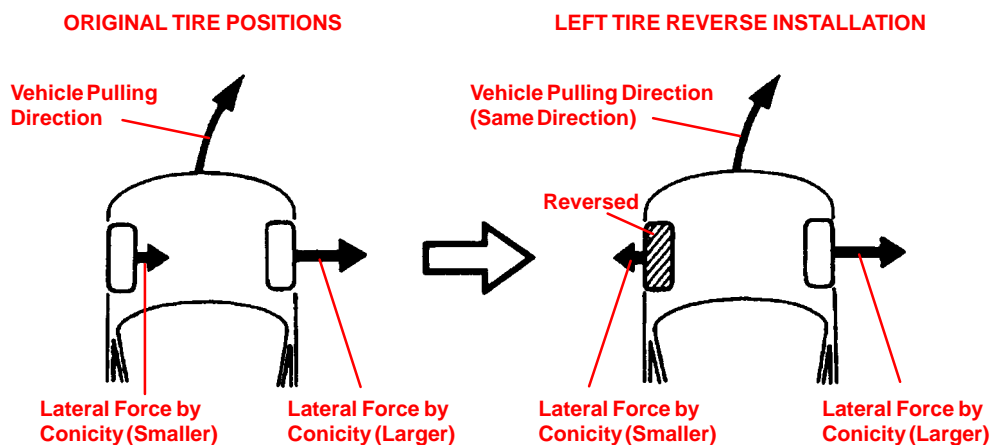
### If Vehicle Pulls in the Same Direction: Go to STEP 2.

The lateral force generated by the right front tire is greater than the left tire, so the vehicle is pulling due to the lateral force of the right tire.

Remove the front left tire from the wheel and reverse the tire. Then perform a road test and check for change in the pulling direction.

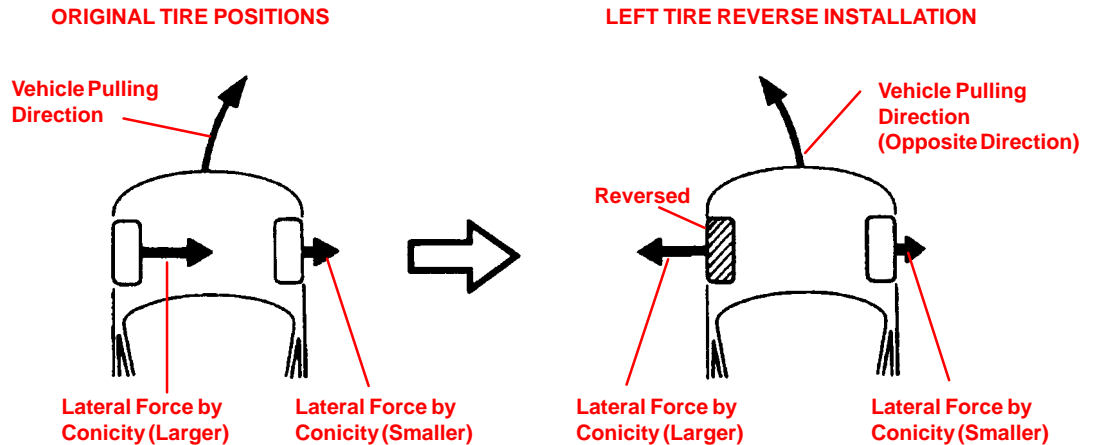
**If Vehicle Pulls in the Opposite Direction: Go to STEP 2.**

The lateral force generated by the left front tire is greater than the right tire, so the vehicle is pulling due to the lateral force of the left tire.

Rotate the **larger** lateral force front tire with the rear tire and check the change in the vehicle pulling.
