# Front Seat Squeak Noise

**Service Category** Vehicle Interior

YEAR(S)	MODEL(S)	ADDITIONAL INFORMATION
2004 – 2008	Prius	Body Type(s): Hybrid Sedan Drive Type(s): 2WD Engine(s): 1NZ Plant Code(s): 3, 7 Transmission(s): COLUMN VDS(s): KB20U, KB22U WMI(s): JTD

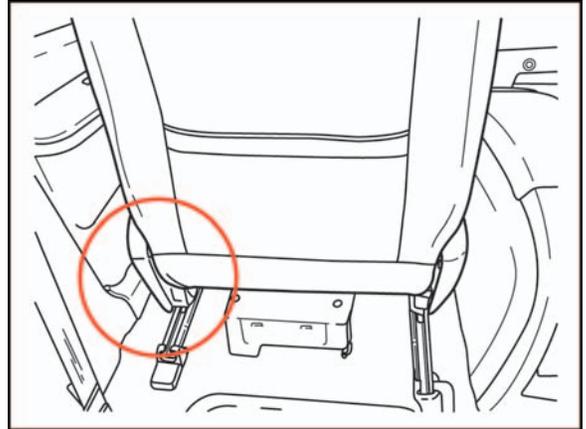
**Figure 1.**

**HINT**  
The circle shows the area that makes the noise.

1. Remove front seat cushion lower shield.
