Microscopic Analysis Report

Customer Name: ROBERT WILSON
Reservoir Description: ZV30 TYPE WS 5K

Sample Date: 09/30/09
Lab Number: 349375

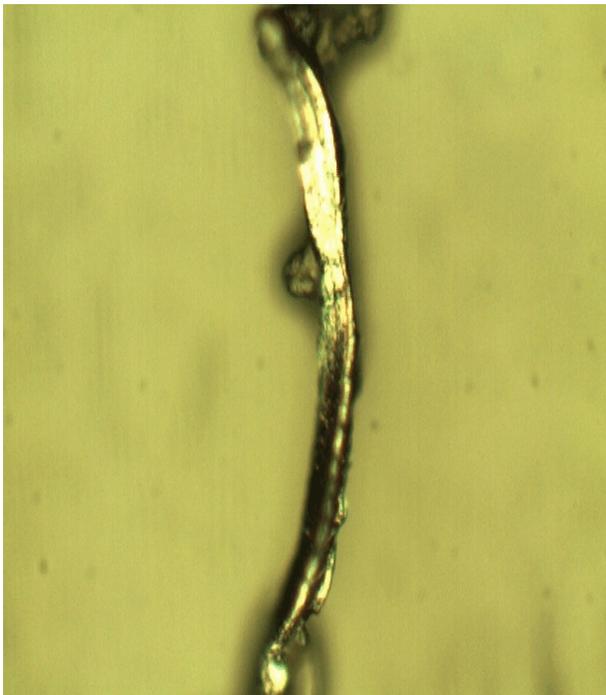
Figure 1: Ferrous Cutting Wear Particles and Abrasive/Dust/Dirt Particles at the Head of the Slide (Magnification 400X).

Ferrogram Interpretation: There were a few ferrous cutting wear particles, metallic spherical wear particles, and red oxide particles present on the slide. Also, a few ferrous rolling wear platelet particles, ferrous/nonferrous white metal rubbing wear particles, and abrasive/dust/dirt particles were found on the slide. The presence of cutting wear particles suggests possible misalignment and/or abrasive contamination. The presence of rolling wear platelet particles suggests possible surface fatigue and/or rolling contact due to metal-to-metal sliding and/or abrasive contamination. The presence of red oxide particles suggests possible past or present water contamination. The presence of metallic spherical wear particles suggests possible rolling bearing fatigue and/or welding or grinding processes(contamination). The morphology of the abrasive/dust/dirt particles suggests possible contamination of the sample and/or reservoir from an external source.

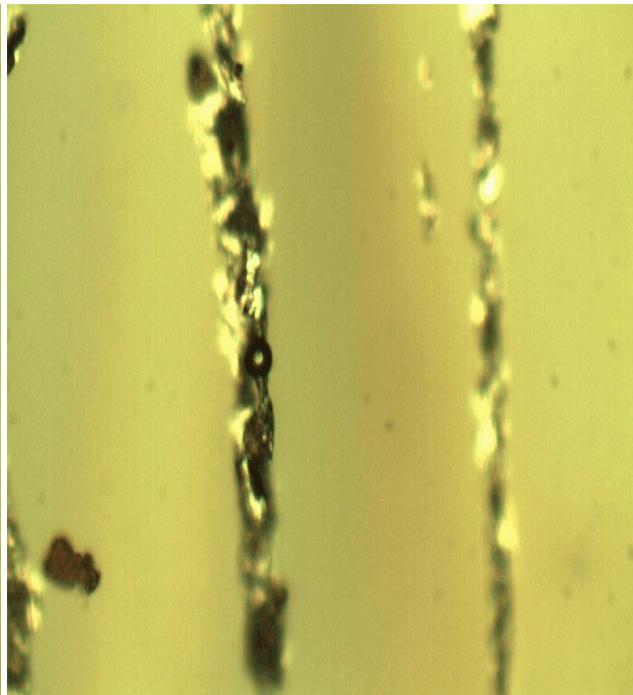
Figure 2: Ferrous Cutting Wear Particle, Metallic Spherical Wear Particles, and Red Oxide Particles at the Head of the Slide (Magnification 400X).
