# Structural Repair Precautions & Specifications

## High Strength Steel Handling Precautions

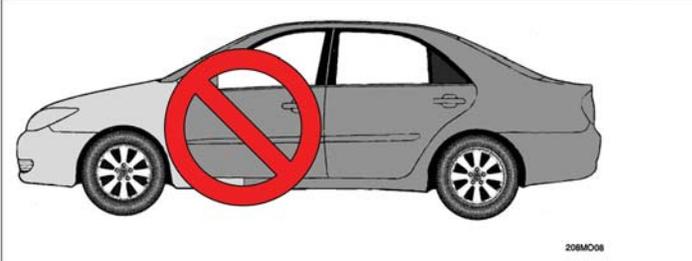
208MO08

Full body sectioning, also known as "clipping" is **NOT** an approved repair procedure on any Toyota or Lexus vehicle.

Full body sectioning is generally done on a vehicle that has sustained severe rear end damage, where the front portion of one vehicle is joined to the rear portion of another vehicle.

Full body sectioning is **not approved** for the following reasons:

- Decrease in strength and safety from the original Toyota/Lexus design
- Poor fit and alignment of the body
- NVH (squeaks, rattles, etc.)
- Wind noises and water leaks
- Diminished protection from rust/corrosion

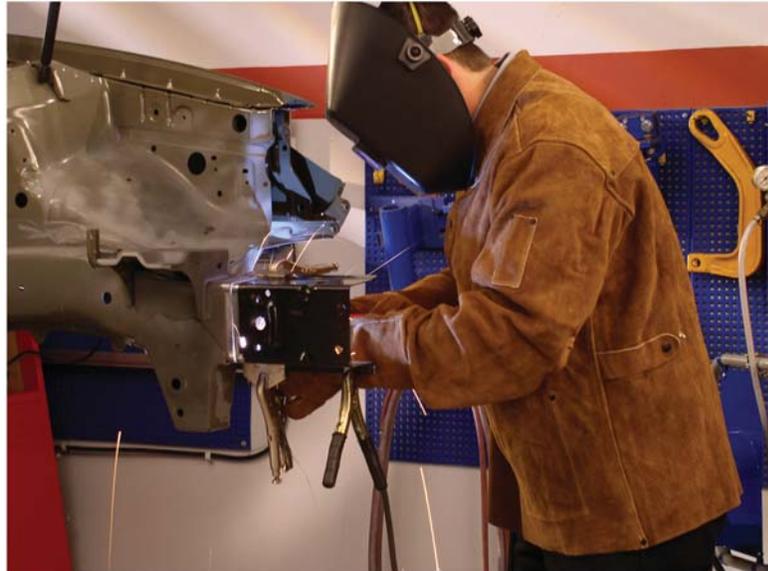
Figure 4-6  
TL460F406

Toyota continuously reviews ways to make component attachment both strong and visually aesthetic, but does not recognize or promote any attachment procedure that is not consistent with those specified in model specific Repair Manuals For Collision Damage. You will find in most cases that structural components require Gas Metal Arc Welding (GMAW), also referred to as Metal Inert Gas (MIG) welding, because of the combined thickness of metal being joined.
