Gen1 Prius Transaxle Service

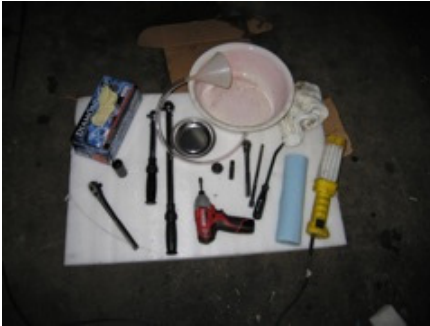
Sockets needed 24mm and 10mm. Rags, bucket, funnel and two feet of 5/8 hose for filling. Bin for bolts. Torque wrenches helpful (67 inch pounds and 36ft pounds). Not shown, rampstands or jackstands to lift front of car.

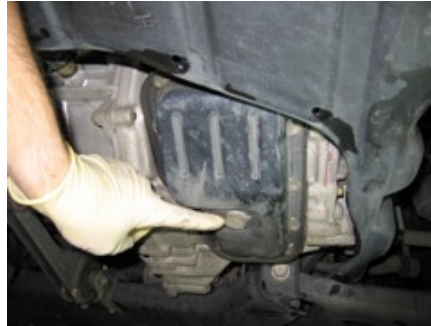
The tranny drain plug is this one, on the drivers side of the car. 24mm.

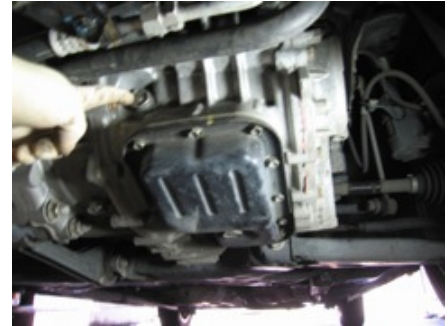
It's worth taking off the drivers side plastic splash guard so you can see better. A bunch of 10mm screws and one phillips plastic barb hold the guard in place. I'm pointing to the fill plug which is easy to see once the splash guard is off.

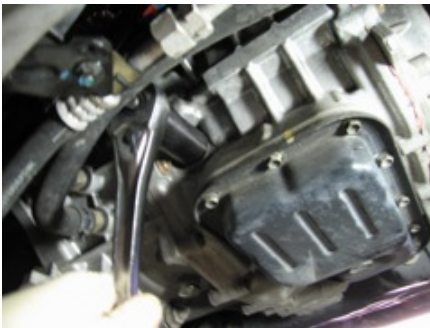
Remove the 24mm fill plug first, it will make the draining smoother. It will hiss when you open since the Prius transaxle is sealed.

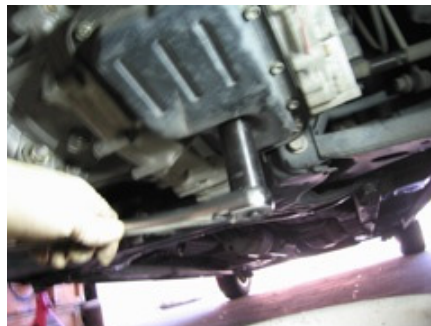
Open the 24mm drain plug and let drain for a few minutes. Hopefully your fluid is more red than black.

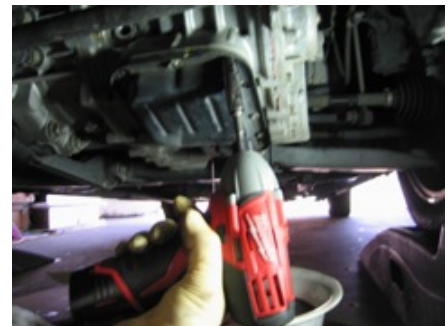
Now remove the twelve 10mm bolts. They have locktite on them so a power driver is helpful here.

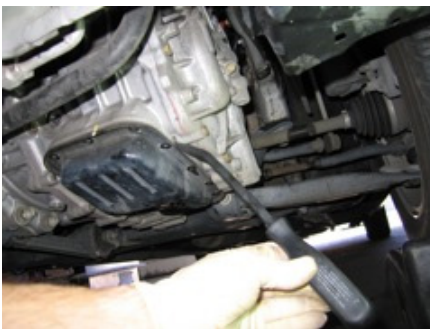
A gentle pry will release the pan. Make sure you hold it with one hand as it comes down and drain any remaining fluid from the pan into your bucket.

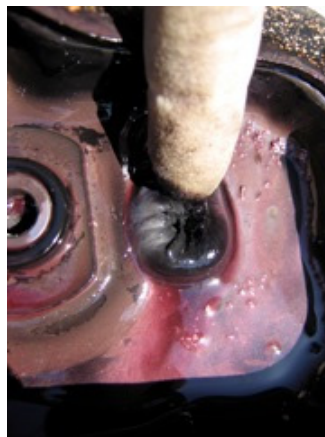
A gray mix of crud surrounds the magnet.

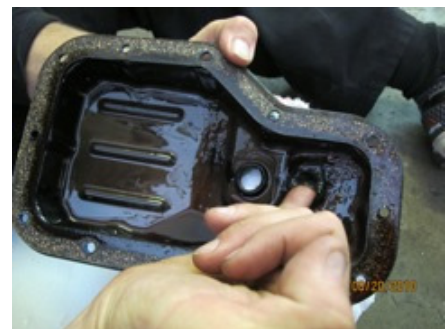
This tranny was "serviced" by the dealer 2000 miles ago...they obviously did not drop the pan and clean it. Shame on them!

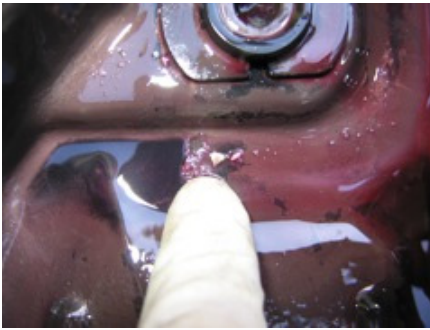
Small specs of crud are typical.

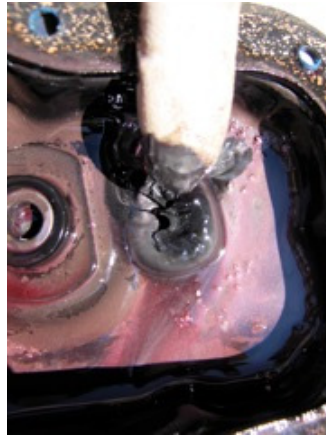
More crud....and magnetic.

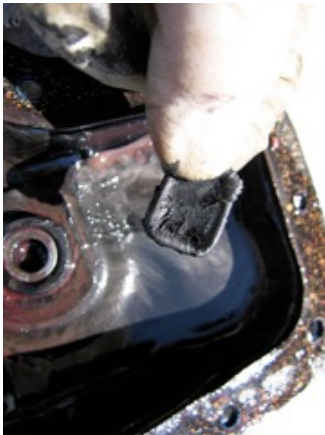
crud crud crud!

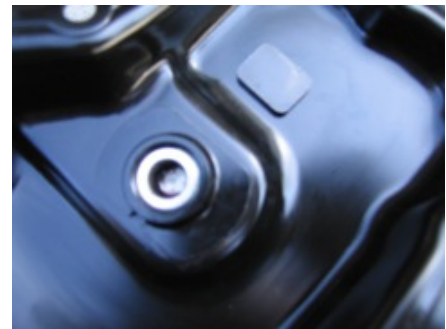
Magnet goes about here.

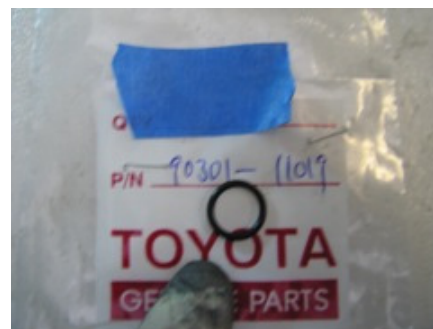
O-ring seal on internal pickup tube. Not usually necessary to remove the pickup tube but if you want to the part number for O-ring is 90301-11019.

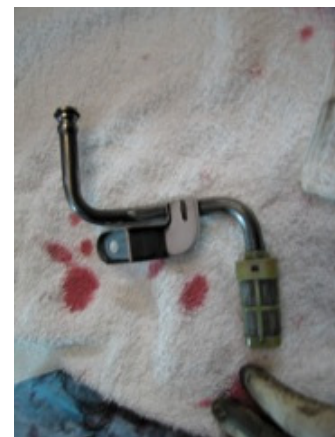
It is very important to clean input screen of the oil pickup tube. You can do this with pickup tube in car. Often the screen is plugged with gunk and after wiping fluid comes out...signifying poor ATF circulation due to plugged screen. If it gets too plugged you'll cook the tranny.

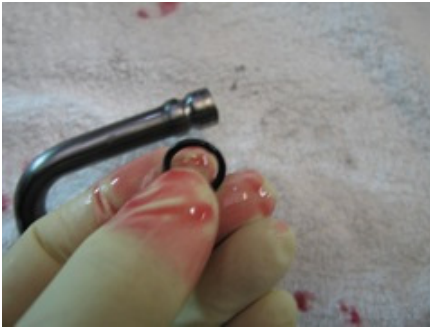
Pickup tube o-ring. Lubricate with ATF and be gentle installing tube into tranny case.

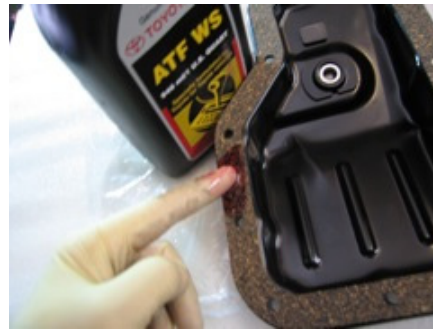
This pan is dented, yours should look better. Apply a thin film of new ATF WS to the cork to aid in removal next time you do this...30,000 miles from now.

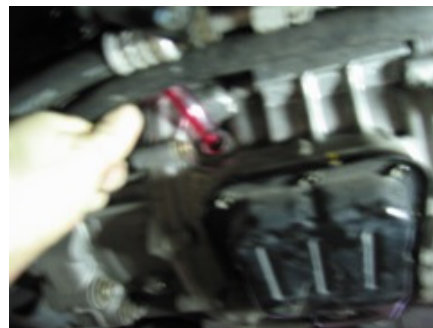
Fluid entering the tranny. Once full carefully remove hose and install fill plug (also with new crush washer) tighten to 36ft pounds. Install splash guard. Road test, check for leaks.
