SUBJECT: SPECIAL SERVICE CAMPAIGN ☐ Y05
(2001 MODEL YEAR PRIUS POWER STEERING GEAR)

2001 MODEL YEAR PRIUS STEERING GEAR SAFETY RECALL NOTICE

SP ECI A L SE RVIC E C AM PA I G N Y05

PO W ER STE ERING GE AR REPLA CEMENT

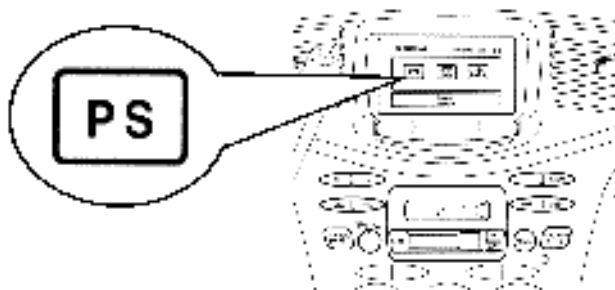
The Prius uses a newly designed electronically assisted power steering system rather than a traditional hydraulic system. Torque sensors, which are built into the power steering gear assembly, may send an improper electrical signal to the power steering electronic control unit (ECU). When this happens the driver will notice a warning icon (shown below) displayed on the center panel, a chime will sound, and higher than normal steering effort may be experienced depending upon vehicle speed.

This condition may be most noticeable at low speed, such as when parking the vehicle. If this should occur, it may be **temporarily** corrected in certain cases if the vehicle is parked, the ignition is turned ☐ OFF ☐ and then turned back ☐ ON ☐

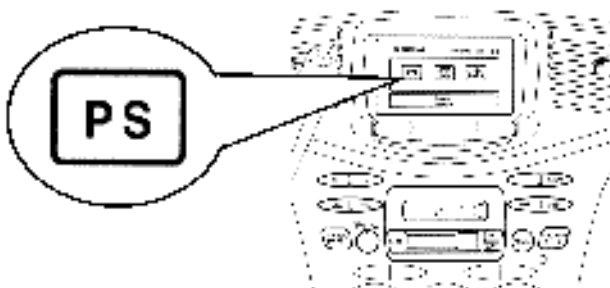
The innovative and environmentally friendly Prius uses a newly designed electronically assisted power steering system rather than a traditional hydraulic system. Special torque sensors, which are built into the power steering gear assembly, may send an improper electrical signal to the power steering electronic control unit (ECU). When this happens you will notice a warning icon (shown below) displayed on the center panel, a chime will sound, and you may experience higher than normal steering effort depending upon vehicle speed.

This condition may be most noticeable at low speed, such as when you are parking your vehicle. If this should occur, it may be **temporarily** corrected in certain cases if the vehicle is parked, the ignition is turned **OFF** and then turned back **ON**.

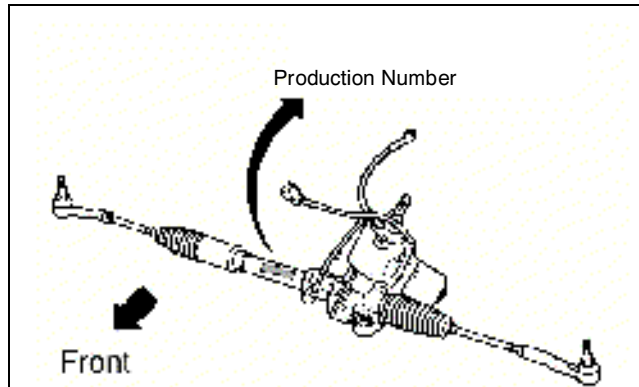
1. INSPECT POWER STEERING GEAR ASSEMBLY LOT NUMBER.
 - (a) Place vehicle on lift.
 - (b) Inspect production number on P/S gear assembly.

Production Range	Action
000001 - 005928	Replace Power Steering Gear Assembly
005929 - 999999	Proceed to Section VI

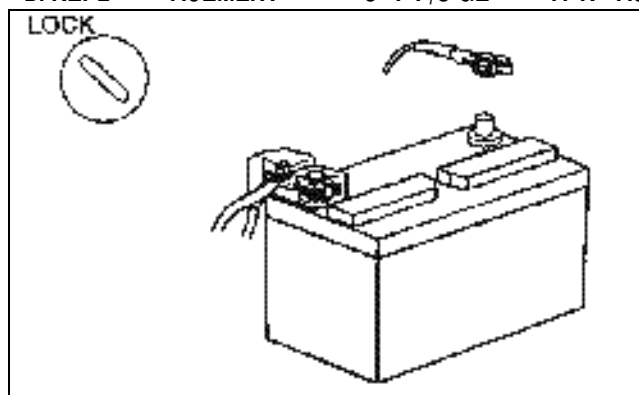
1. DISCONNECT NEGATIVE (-) BATTERY TERMINAL
 - (a) Record radio station presets.
 - (b) Turn the ignition key to the **LOCK** position.
 - (c) Disconnect negative (-) battery terminal.

Battery is located in the luggage compartment on the left side.

Do not remove the Steering Wheel Pad until a minimum of 90 seconds has passed since the ignition key was set in the **LOCK** position and the battery has been disconnected.

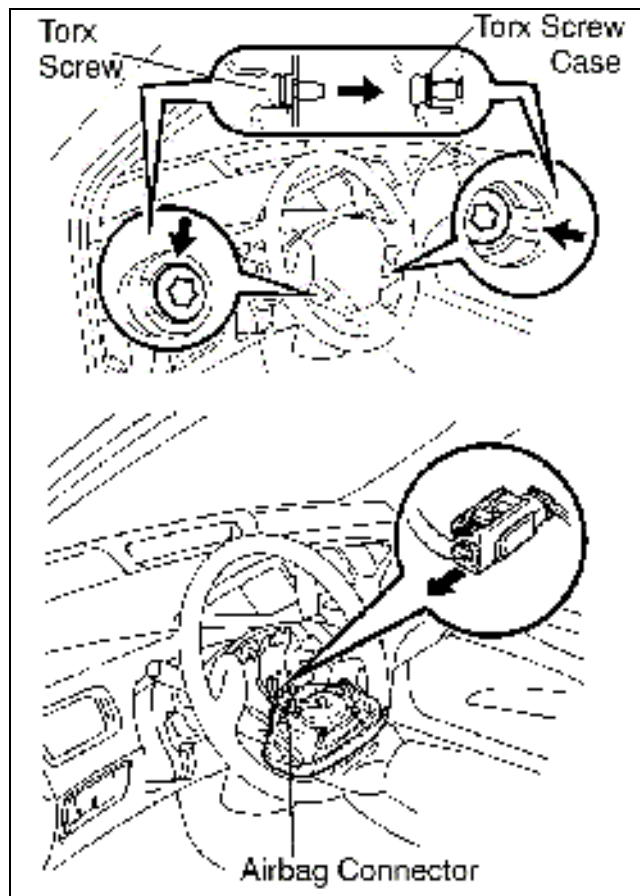
2. REMOVE STEERING WHEEL

If the airbag is disconnected with the ignition in the ON or ACC position, a DTC will be recorded.

- Turn the steering wheel so the front wheels face straight ahead.
- Remove the two covers behind the steering wheel to expose the Torx screws.

- Using a T30 Torx socket, loosen the screws.
- Remove wheel pad and disconnect the air bag connector.

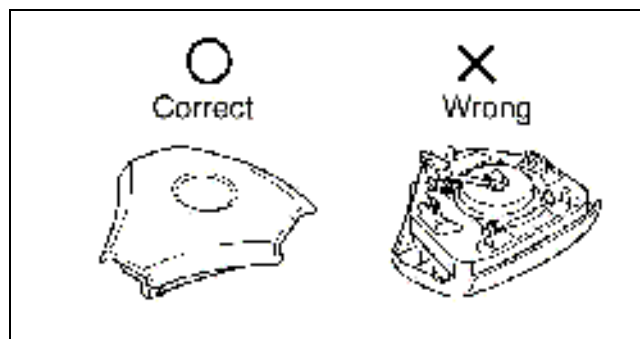
- Loosen the Torx® screws until the groove, along the screw circumference, catches on the screw case.
- Be careful not to damage the cruise control switch, if equipped.
- Never store the wheel pad with the pad facing down.

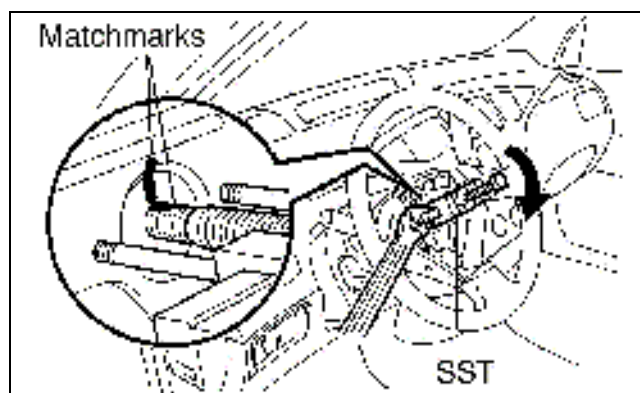
3. REMOVE STEERING WHEEL

- Remove the steering wheel set nut.
- Place matchmarks on the steering wheel and steering shaft.
- Using SST, remove steering wheel.

SST 099 50-5 0012 (or equivalent)

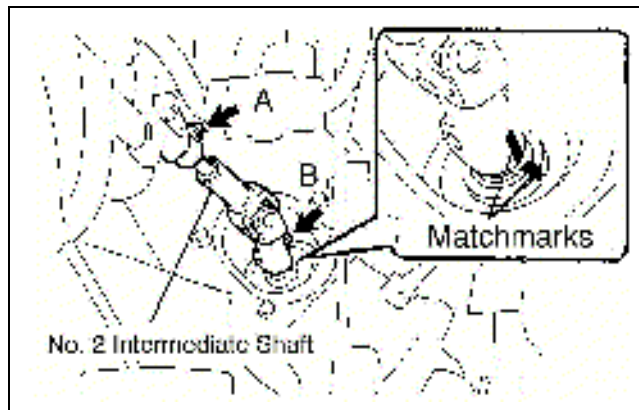
4. DISCONNECT No. 2 INTERMEDIATE SHAFT

- Remove the plastic cover from around the No. 2 intermediate shaft.
- Place matchmarks on the No. 2 intermediate shaft assembly and the control valve shaft.
- Loosen bolt A and remove bolt B.
- Disconnect the No. 2 intermediate shaft from the control valve shaft.

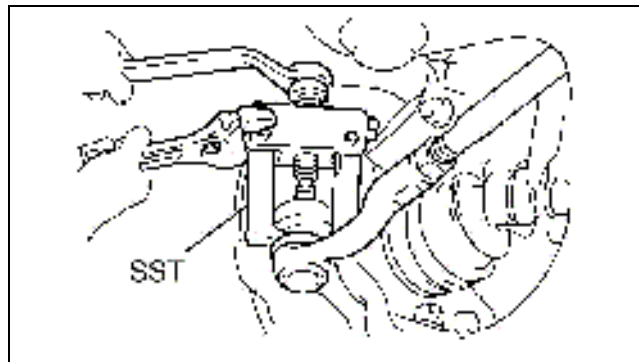
- Disconnect both tie rod ends from the steering knuckles.
 - Remove the cotter pin and nut from each tie rod end.
 - Using SST, disconnect the tie rod ends from the steering knuckle.

SST 096 28-6 2011 (or equivalent)

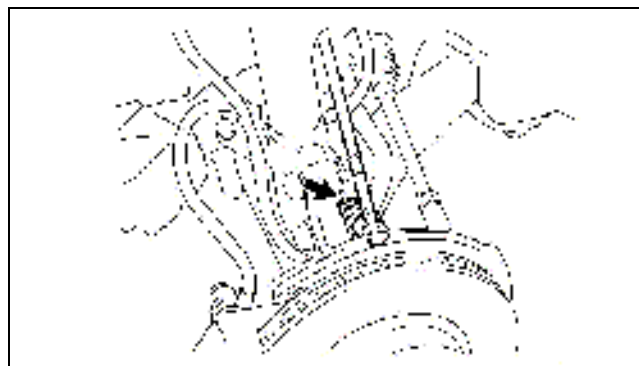
- Disconnect both stabilizer links.
 - Remove the nut and disconnect the stabilizer bar link from each shock absorber.

If the stabilizer link ball joint turns with the nut, use a hex wrench to hold the ball joint stud.

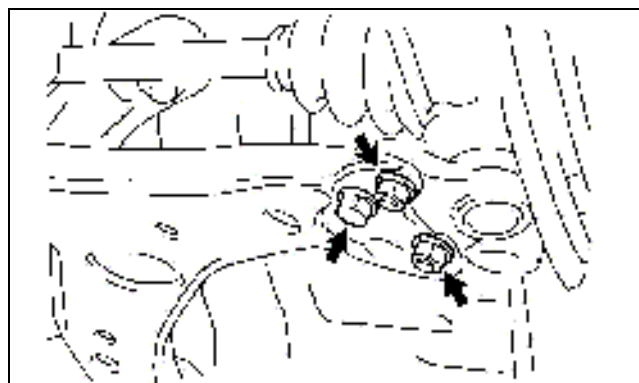
- Disconnect both lower suspension arms from the lower ball joints.
 - Remove the bolt and 2 nuts from each ball joint, and disconnect the lower control arm from the joint.
- Support front suspension crossmember with a transmission jack.

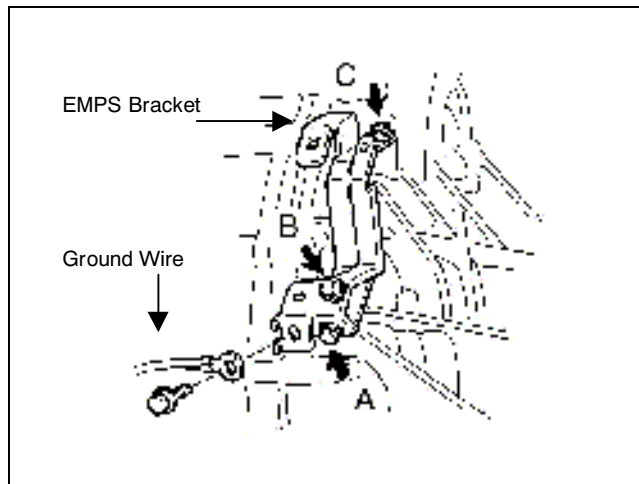
- (h) Disconnect the 2 connectors and remove the Electric Motor Power Steering (EMPS) bracket.
- (1) Remove the 2 wire harness clamps from the EMPS bracket.
 - (2) Remove bolt

A and separate the EMPS bracket by slightly lifting the right side of the EMPS bracket.
 - (3) Remove and disconnect the 2 connectors from the EMPS bracket.
 - (4) Remove the bolt for the ground wire.
 - (5) Remove bolt

B and

C and the EMPS bracket.

It may be necessary to slightly lower the front crossmember to gain access to the connectors.

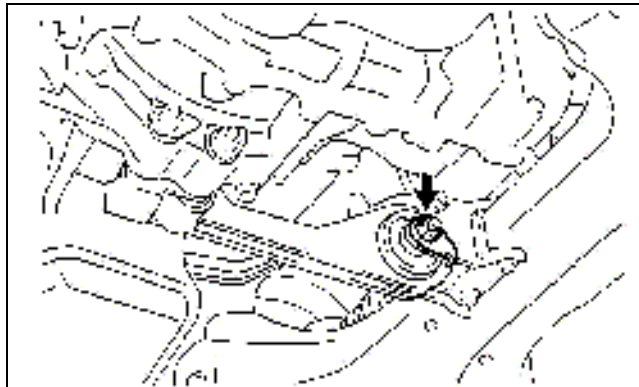
- (i) Remove the nut and bolt, then disconnect the torque rod from the suspension member.

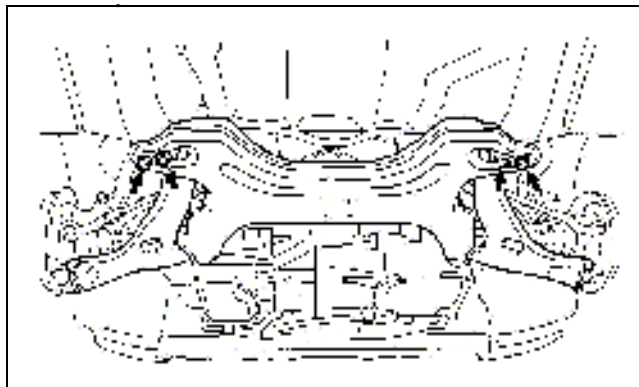
- (j) Remove the 4 bolts, and lower the front crossmember from the body using a transmission jack.

Ensure that the connectors of the P/S system have been disconnected removing the front crossmember.

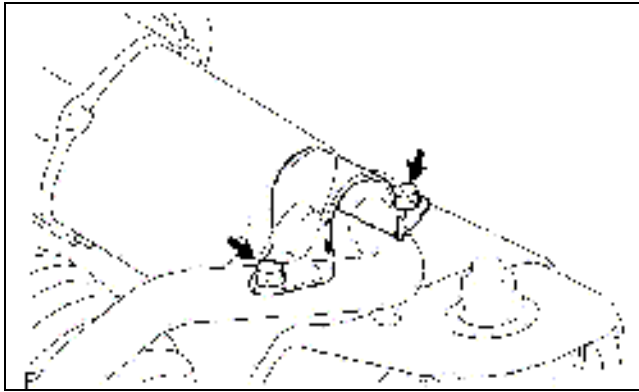
6. REMOVE THE P/S GEAR ASSEMBLY.

- (a) Remove the stabilizer bar.
 - (1) Remove the 4 bolts, 2 brackets and bushings.
 - (2) Remove the stabilizer bar.
- (b) Remove the 4 bolts and P/S gear assembly from the front crossmember.
- (c) Remove the bracket and grommet from the P/S gear assembly.

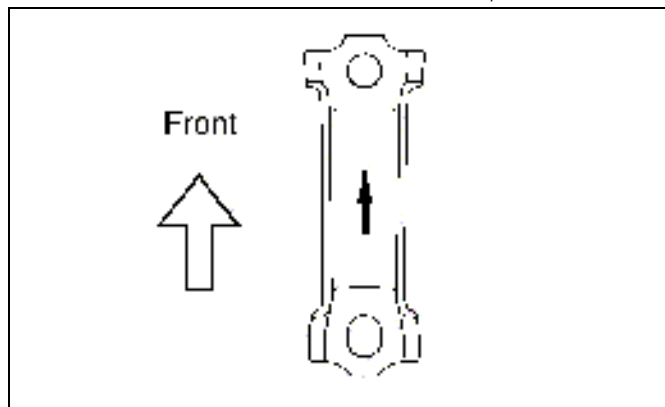
1. INSTALL NEW P/S GEAR ASSEMBLY.

- (a) Reinstall the grommet and bracket to the new P/S gear assy.

The bracket is inscribed with a mark that must face towards the front of the vehicle.

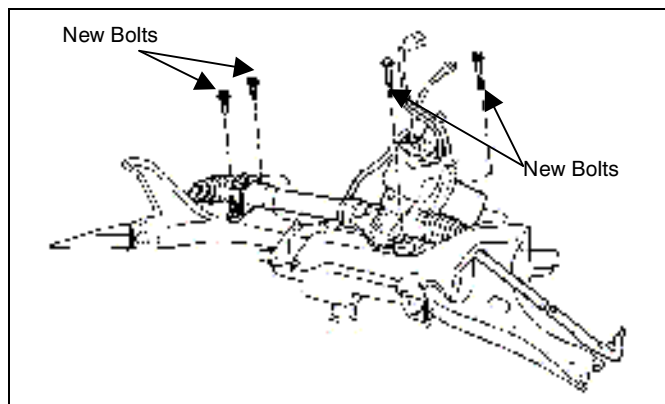
- (b) Install the new P/S gear assy. using the 4 new bolts to the front crossmember.

TORQUE: 83 N •m (85 0 kg f •cm, 61 f t •lb f)

- (c) Reinstall the stabilizer bar.

TORQUE: 19 N •m (19 5 kg f •cm, 14 f t •lb f)

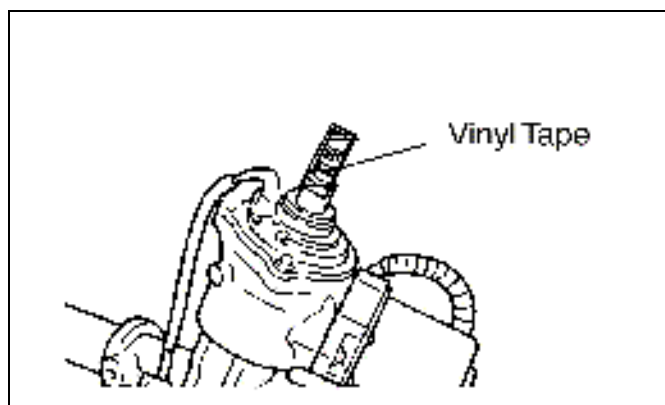
- (d) To prevent damage to the lower main shaft dust shield, wrap the control valve shaft with vinyl tape.

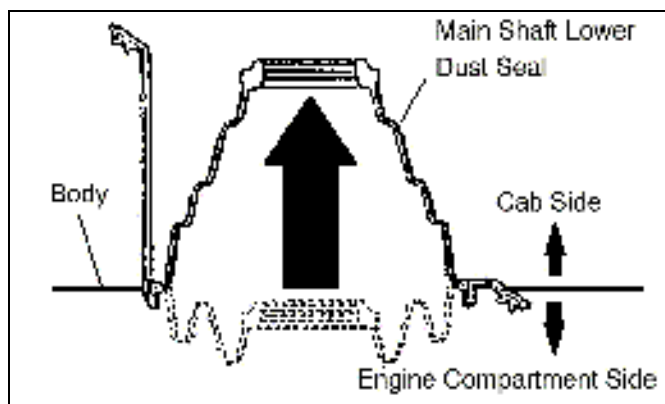
- (e) Gently push the lower main shaft dust shield into the interior of the vehicle.

- (a) Using the transmissions jack raise the front crossmember and position it to the body.

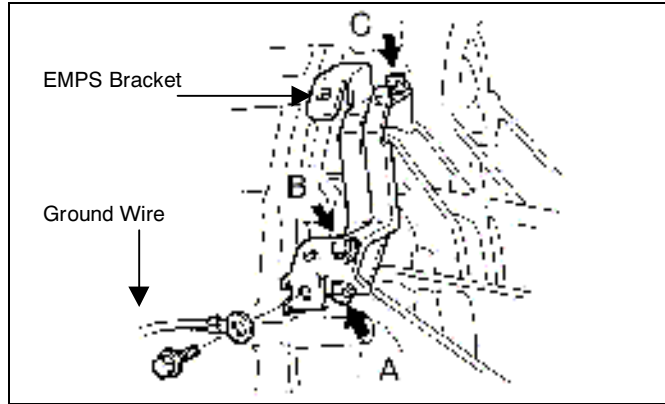
- (b) Reconnect the 2 connectors and reinstall the EMPS bracket using bolts **A**, **B** and **C**.

TORQUE: 5.5 N •m(60 kg f •cm, 52 in •lb f)

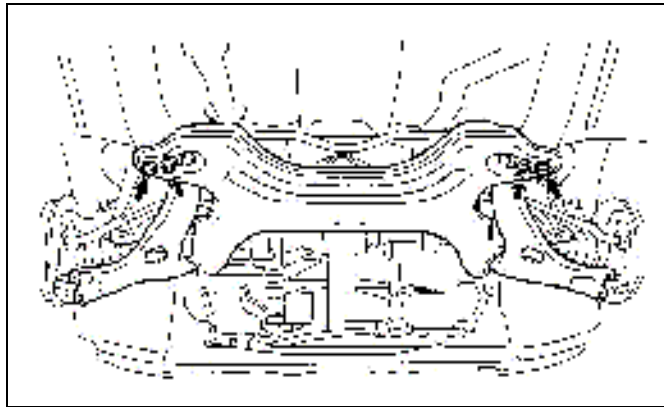
- (e) Reinstall and torque the 4 front crossmember bolts.

Front 113 N •m(1,152 kg f •cm, 83 ft •lb f)

Rear 157 N •m(1,600 kg f •cm, 116 ft •lb f)

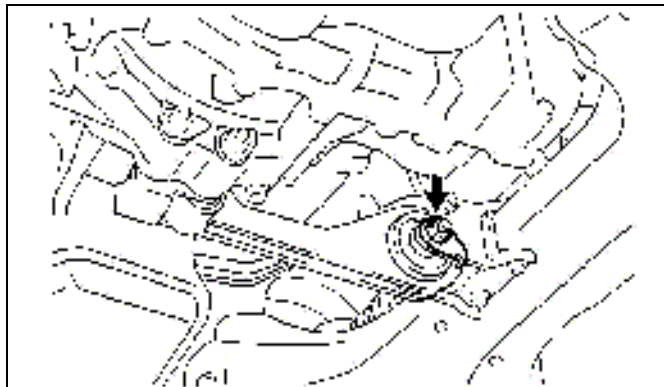
- (f) Reconnect the torque rod to the front crossmember with the nut and bolt.

TORQUE: 100 N •m(1,030 kg f •cm, 74 ft •lb f)

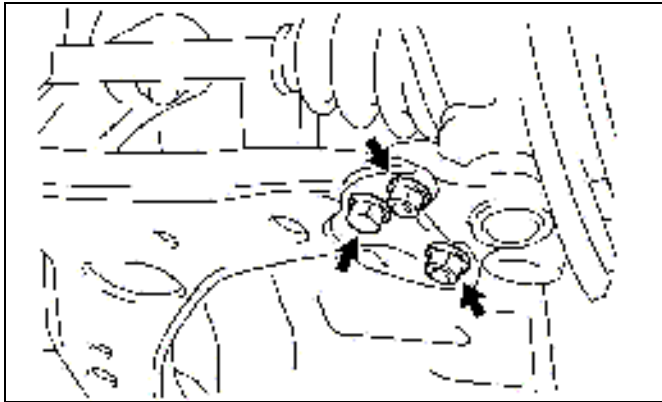
- (g) Reconnect both lower control arms to the ball joints using the bolt and 2 nuts.

TORQUE: 142 N •m(1, 450 k gf •cm,
105 ft •lbf)

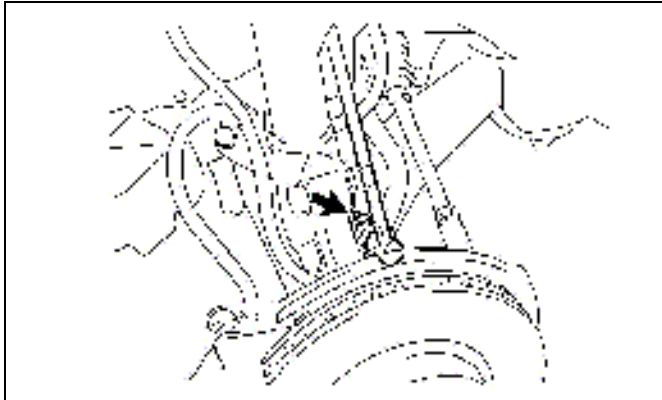
- (h) Reconnect both of the stabilizer bar links to the shock absorber.

TORQUE: 74 N •m(75 5 kg f •cm, 55 f t •lb f)

If the stabilizer link ball joint turns with the nut, use a hex wrench to hold the ball joint stud.

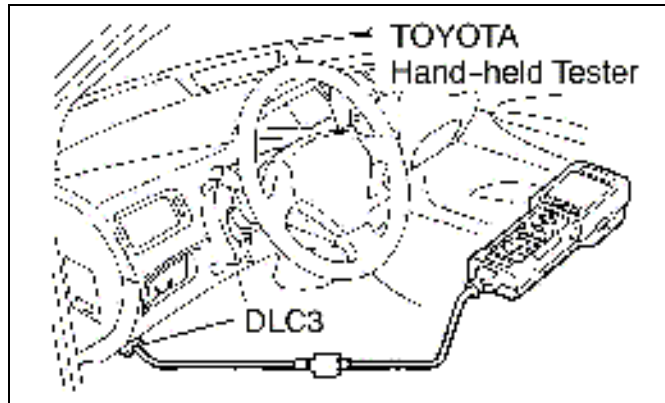
5. CAL IBR ATE P/S TORQUE SENSOR ZERO POINT.
 (a) Calibration of torque sensor zero point.
 (1) Stop the vehicle.
 (2) Connect the Toyota hand-held scan tool to the DLC3.
