SRS Light "ON" DTC B1821/B1826 Open Front Side Squib Circuit

Service Category Vehicle Interior

Section Supplemental Restraint Systems

YEAR(S)	MODEL(S)	ADDITIONAL INFORMATION
2004 – 2009	Prius

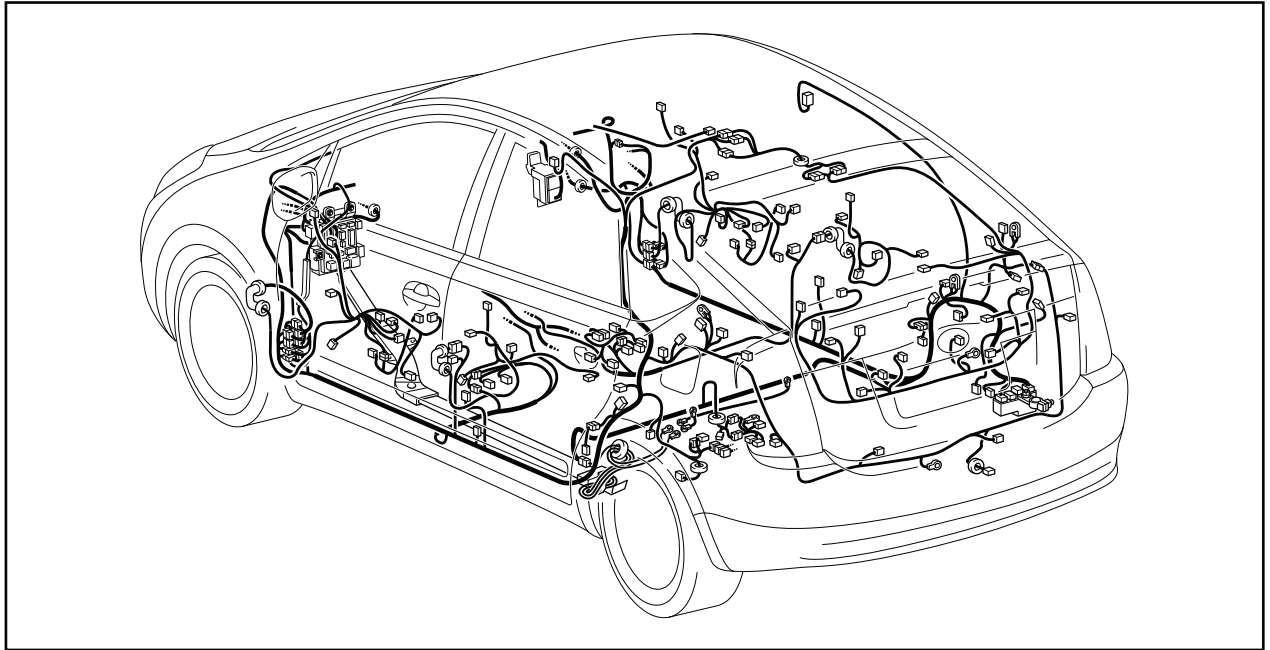
Figure 1. Floor Harness Routing

The right floor harness is routed from the right kick panel to the auxiliary (12V) battery and branches off to the following components:

- Right seat and SRS ECU
- Right front seat belt
- Right rear door
- Across the rear seat to the fuel tank and then to the left floor harness
- Right Curtain Side Airbag
- HV cooling fan
- 12V Battery

The left floor harness is routed from the Body ECU to the right taillight and branches off to the following components:

- Left seat and SRS ECU
- Left front seat belt
- Left rear door
- Left Curtain Side Airbag and roof harness
- HV Battery
- Rear headlight level sensor (if equipped located under vehicle)
- Left and right taillights

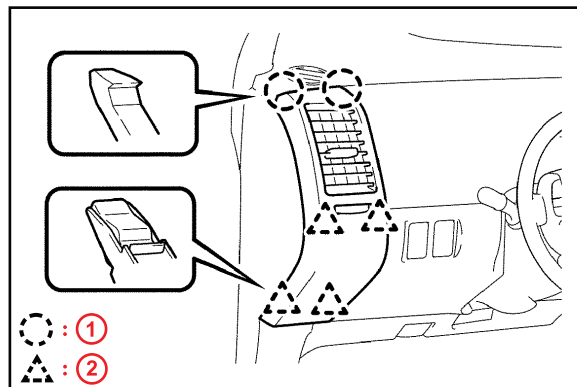
Figure 2.

3. Remove the No. 1 instrument panel register assembly. **(B, L, R)**

Detach the 2 claws and 4 clips, and remove the instrument panel register.

1	Claws
2	Clips

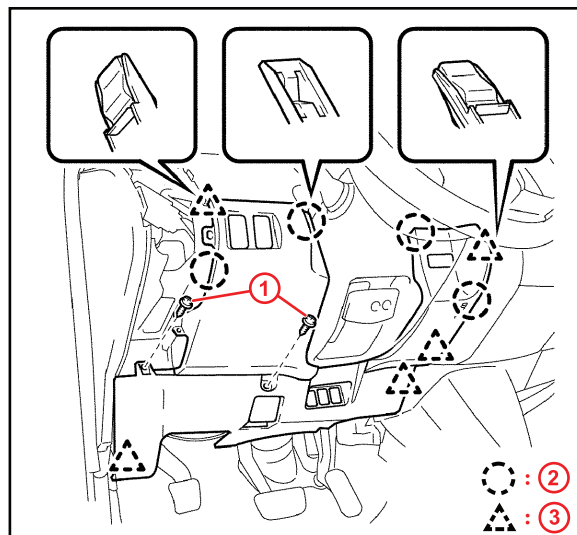
Figure 3.

4. Remove the lower instrument panel finish panel sub-assembly. **(B, L, R)**

- A. Remove the 2 screws.
- B. Disconnect the hood lock control cable.
- C. Detach the 4 claws and 5 clips.
- D. Disconnect all connectors and remove the instrument panel finish panel.

1	Screws
2	Claws
3	Clips

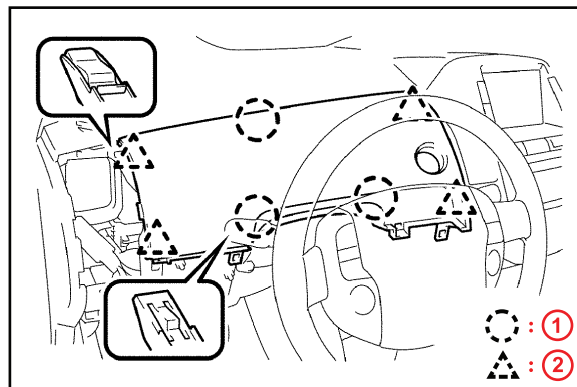
Figure 4.

5. Remove the upper instrument panel finish panel sub-assembly. **(B, L, R)**

- A. Detach the 3 claws and 4 clips.
- B. Disconnect the connector and remove the instrument panel finish panel.

1	Claws
2	Clips

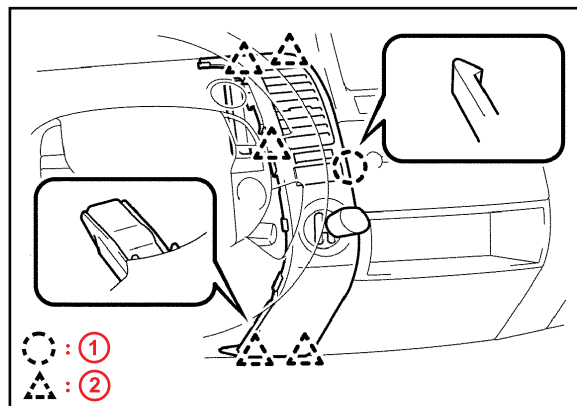
Figure 5.

6. Remove the No. 3 instrument panel register assembly. **(B, L, R)**

- A. Detach the claw and 5 clips.
- B. Disconnect the connector and remove the instrument panel register.

1	Claw
2	Clips

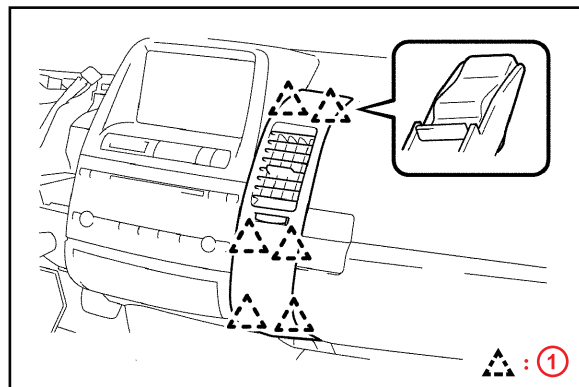
Figure 6.

7. Detach the 6 clips and remove the No. 4 instrument panel register assembly. **(B, L, R)**

1	Clips
---	-------

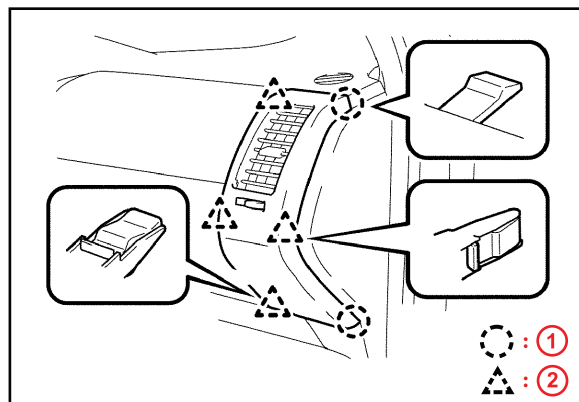
Figure 7.

8. Remove the No. 2 instrument panel register assembly. **(B, L, R)**

Detach the 2 claws and 4 clips, and remove the instrument panel register.

1	Claws
2	Clips

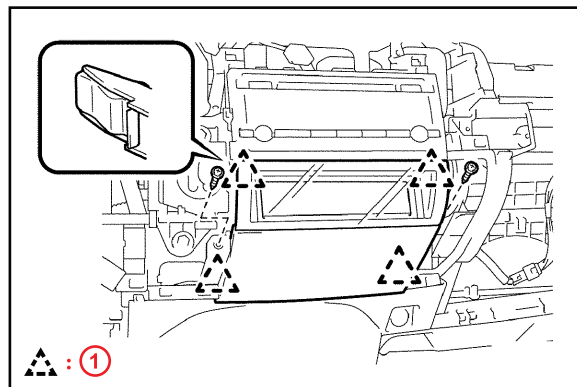
Figure 8.

9. Remove the instrument cluster finish panel assembly center. **(B, L, R)**
 - A. Remove the 2 screws.
 - B. Detach the 4 clips and remove the instrument cluster finish panel.

1	Clips
---	-------

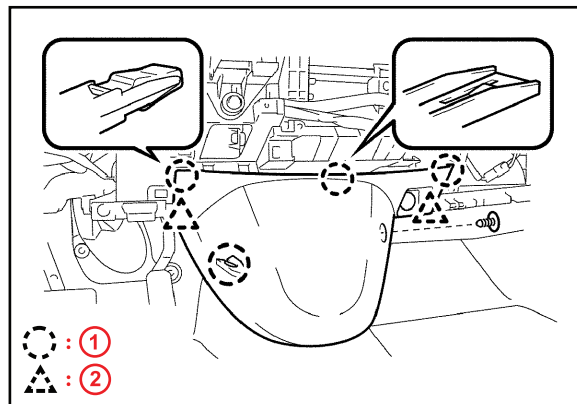
Figure 9.

10. Remove the instrument cluster finish panel assembly center. **(B, L, R)**
 - A. Using a clip remover, remove the clip from the instrument panel finish panel lower center.
 - B. Detach the 4 claws and 2 clips, and remove the instrument panel finish panel.

1	Claws
2	Clips

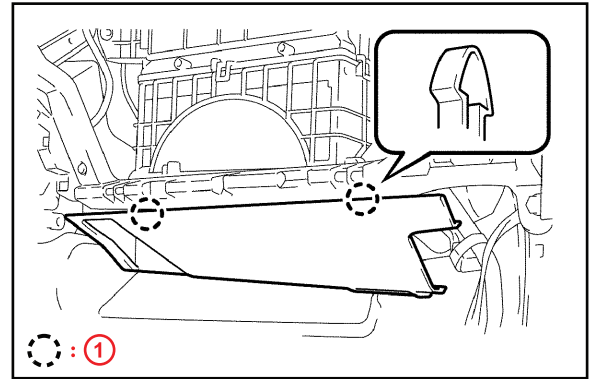
Figure 10.

11. Remove the No. 1 instrument panel under cover sub-assembly by detaching the 2 claws.(B, L, R)

1 Claws

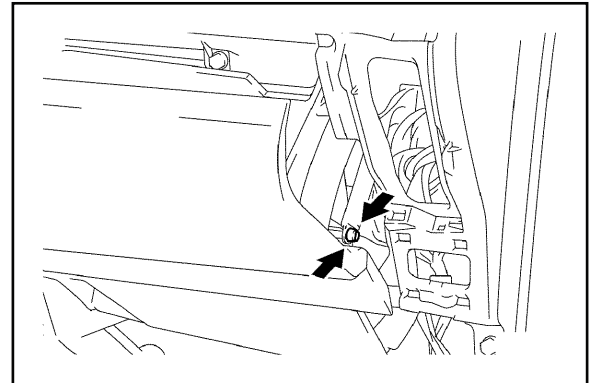
Figure 11.

12. Remove the glove compartment door stopper sub-assembly. (B, L, R)

Holding the part indicated in the illustration, remove the glove compartment door stopper from the glove compartment door.

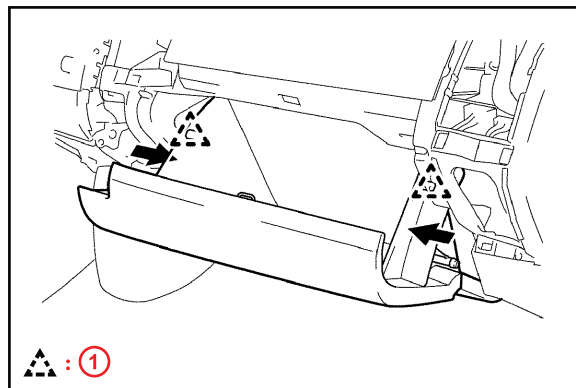
Figure 12.

13. Remove the glove compartment door assembly. **(B, L, R)**

- A. While pushing in the sides of the glove compartment door as indicated by the arrows, open the door to release it from the 2 stoppers.

1 Stoppers

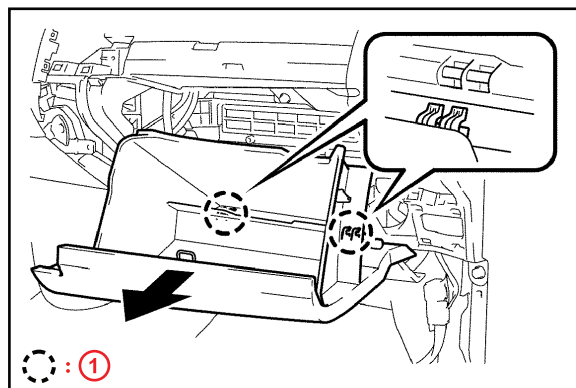
Figure 13.

- B. Open the door until it is horizontal.
- C. Pull the glove compartment door toward the rear of the vehicle to detach the 2 hinges and remove the glove compartment door.

1 Hinges

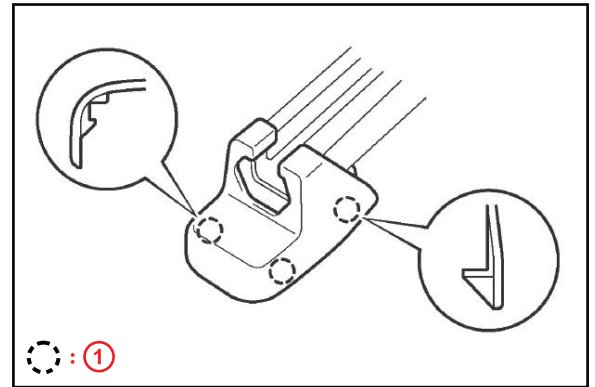
Figure 14.

- A. Using a plastic pry tool (or equivalent), disengage the 3 claws and remove the seat track outer cover LH.

1	Claws
----------	-------

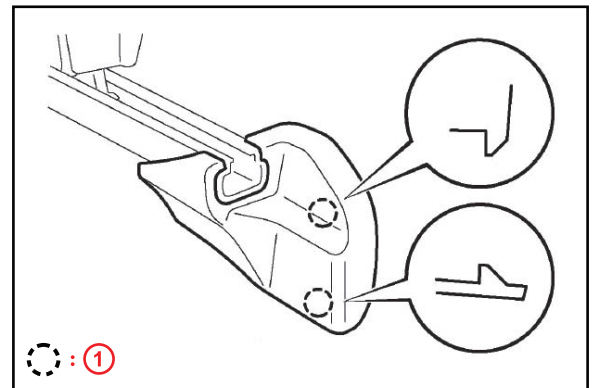
Figure 15.

- B. Using a plastic pry tool (or equivalent), disengage the 2 claws and remove the seat track bracket cover inner LH.

1	Claws
----------	-------

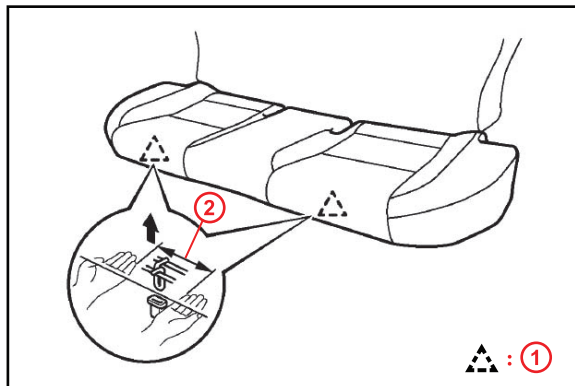
18. Remove the rear seat cushion assembly. **(B, L, R)** **Figure 16.**

Pull up the 2 front portions of the seat cushion, then remove it.

The cushion frame deforms easily. To avoid deforming the seat cushion, place your hands near the hook and on both sides of the hook, and then pull up on the seat cushion. Do the same for all the hooks.

1	Hooks
2	100 mm (3.94 in.) or less

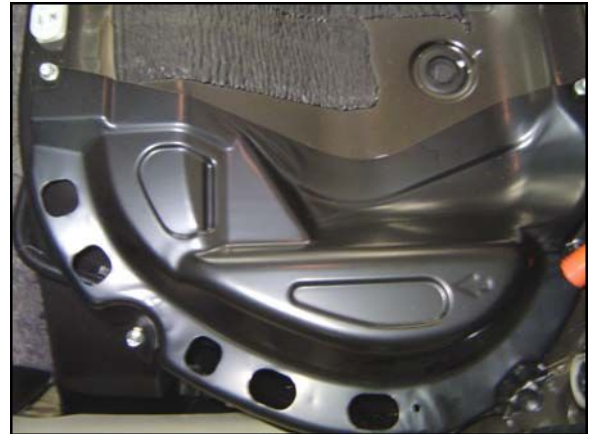
Figure 17.

19. Remove the floor panel left side. **(B, L, R)**

- A. Remove the 3 bolts and 1 clip.
- B. Remove the bracket.

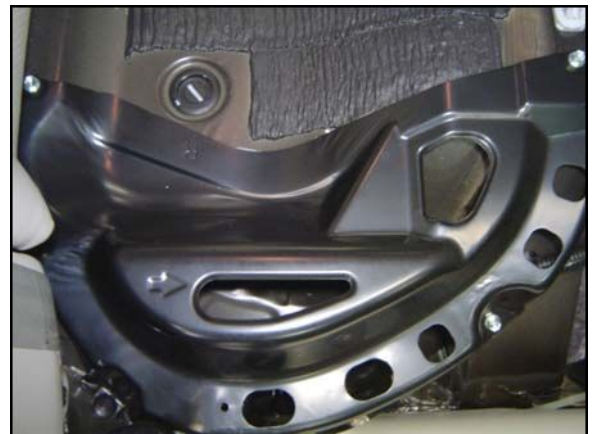
Figure 18.

20. Remove the floor panel right side. **(B, R)**

- A. Remove the 3 bolts and 1 clip.
- B. Remove the bracket.

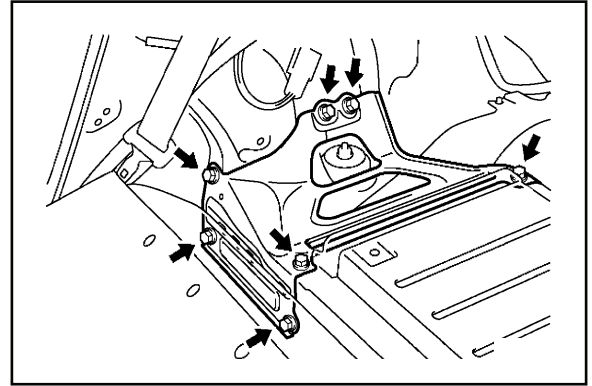
Figure 19.

22. Remove the battery bracket reinforcement by removing the 7 bolts. **(B, L)**

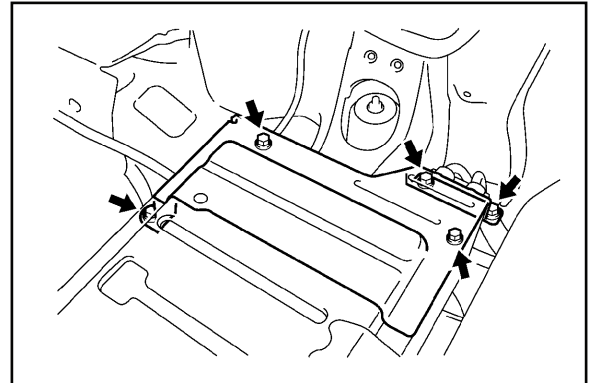
Figure 20.

23. Remove the No. 6 battery carrier panel by removing the 3 bolts and 2 nuts. **(B, L)**

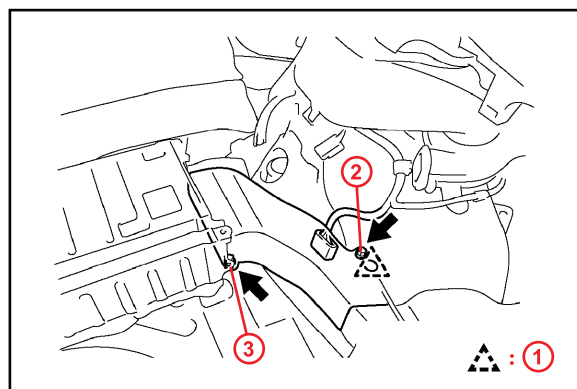
Figure 21.

27. Remove the quarter vent duct. **(B, R)**

- Disconnect the connector.
- Remove the clamp, then disconnect the wire harness.
- Remove the bolt, clip, and the quarter vent duct.

1	Clamp
2	Bolt
3	Clip

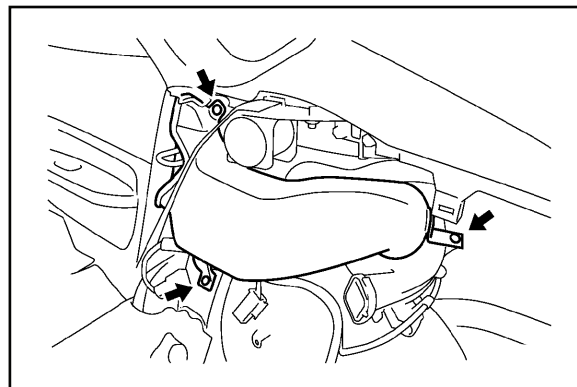
Figure 22.

28. Remove the 3 clips and the ventilator duct inner. **(B, R)**

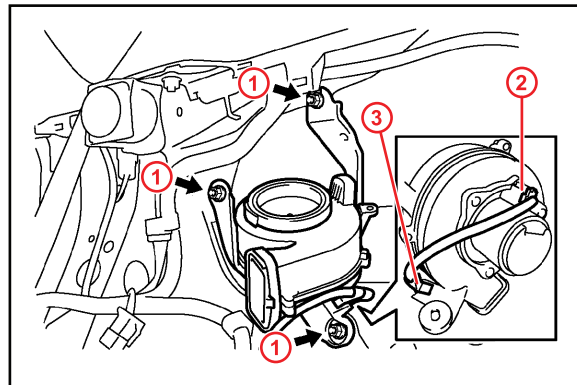
Figure 23.

29. Remove the battery blower. **(B, R)**

- A. Remove the 3 nuts, then disconnect the battery blower assembly from the vehicle.
- B. Remove the connector, clamp, and battery blower.

1	Nuts
2	Connector
3	Clamp

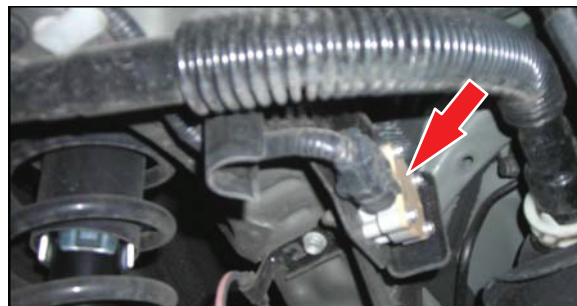
Figure 24.

For vehicles equipped with auto leveling headlights, the left harness is connected to the rear leveling sensor mounted under the vehicle (see Figure 24).
