Fender Rattle/Tick Noise

YEAR(S)	MODEL(S)	ADDITIONAL INFORMATION
2010 – 2011	Prius

Some 2010 - 2011 model year Prius vehicles may exhibit a condition where there is a ticking/rattle type noise from the A-pillar area on either side of the vehicle. This noise has also been identified as a ticking/rattling type noise from the instrument panel. Revised upper fender retainer clips have been developed to address this condition.

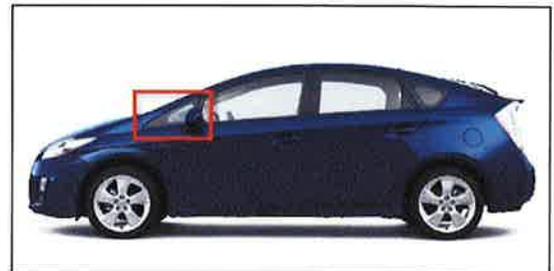
Figure 1. Overview

1. Confirm that the noise/rattle is coming from underneath the fixed side window. Do this by road testing the vehicle. Once the noise is duplicated, roll down the window and apply pressure with your hand to the upper portion of the fender to see if the noise stops.
 - If the noise can be heard and goes away when pressure is applied, this bulletin may apply.
 - If **NOT** this bulletin does not apply. Continue to diagnose the vehicle to find the source of the noise/rattle.

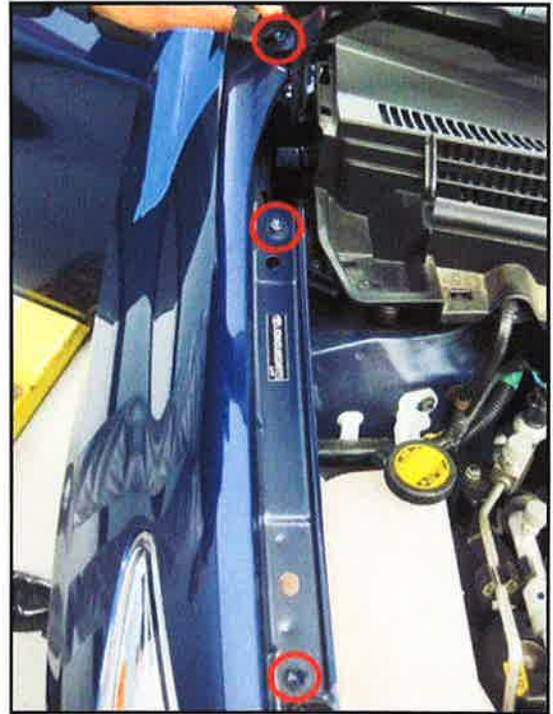
Figure 2.

A. Remove the 3 bolts to detach the fender from the body.

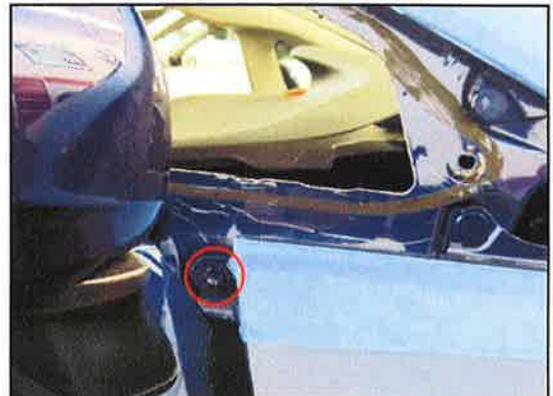
Figure 3.

B. Open the front door and remove the topmost bolt holding the fender to the body.

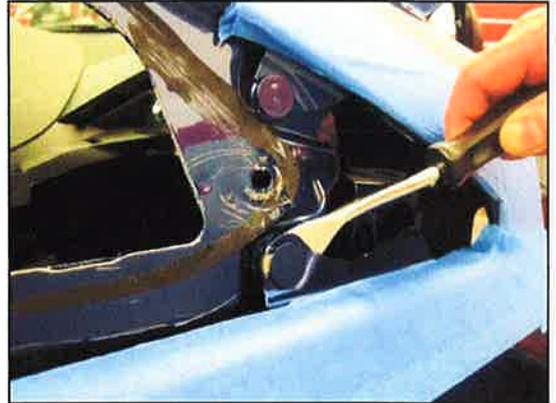
Figure 4.

- C. Using a pry tool, gently remove the 2 retainer clips holding the fender in place.

When removing clips, be sure not to damage the fender sheet metal by exerting too much force.

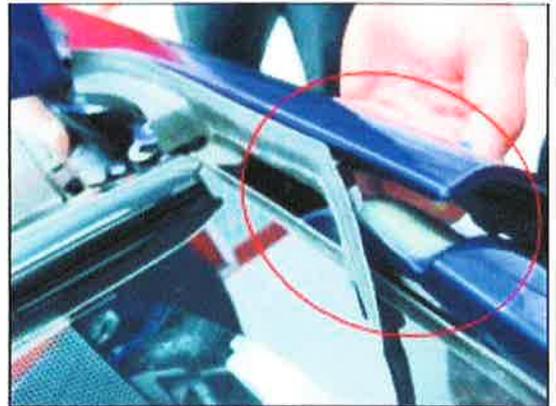
Figure 5.

- D. Separate the front fender to cowl seal from the A-pillar and slightly pull the fender away from the vehicle, then slide the fender retainer clips off of the panel.

Ensure that you do not pull excessively on the fender to prevent from causing any damage.

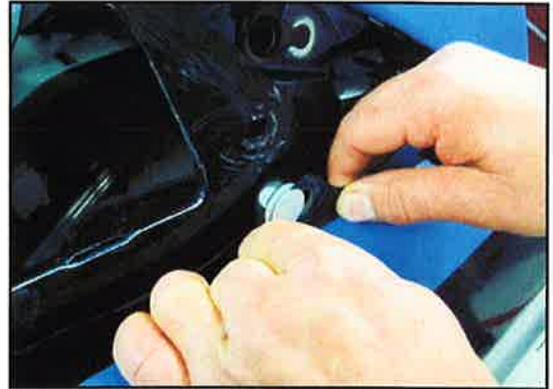
Figure 6.

- E. Slide the new clips into the fender, making sure they are seated properly.

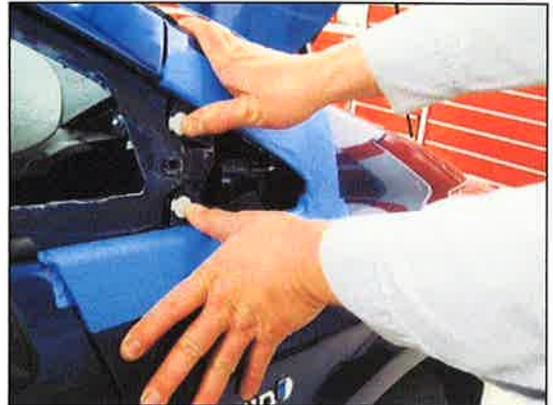
Figure 7.

- F. Guide the clips into their corresponding mounting holes and apply pressure to make sure that the clips seat fully.

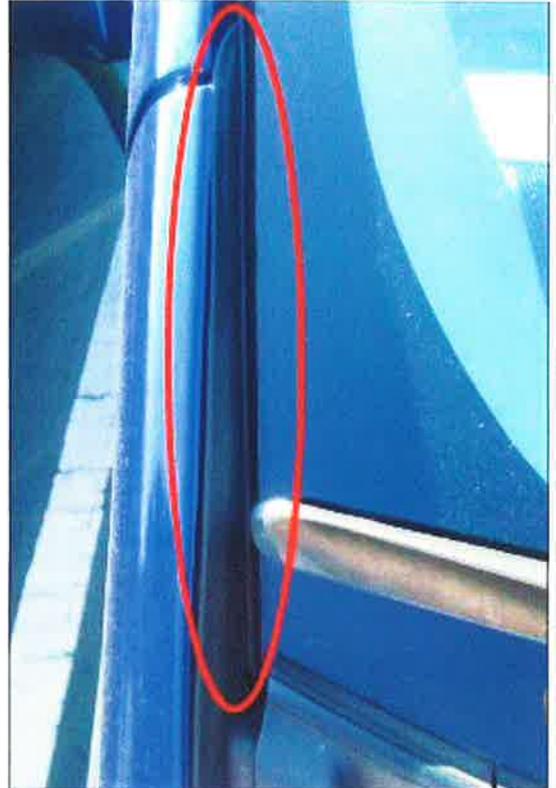
Figure 8.

- G. Use general purpose weatherstrip adhesive to glue the front fender to cowl seal back onto the A-pillar.

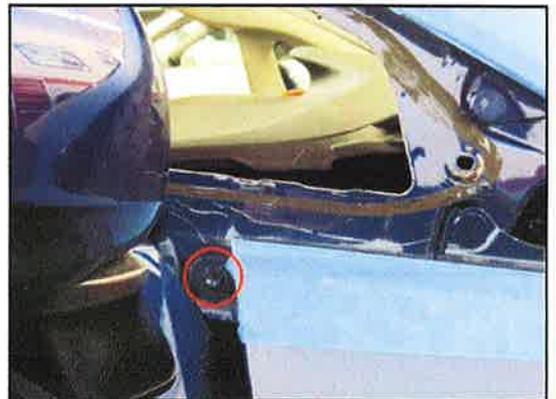
Figure 9.

- A. Open the front door and install the top most bolt holding the fender to the body.

Torque: 13.5 N*m (1.38 kgf*cm, 10 ft*lbf)

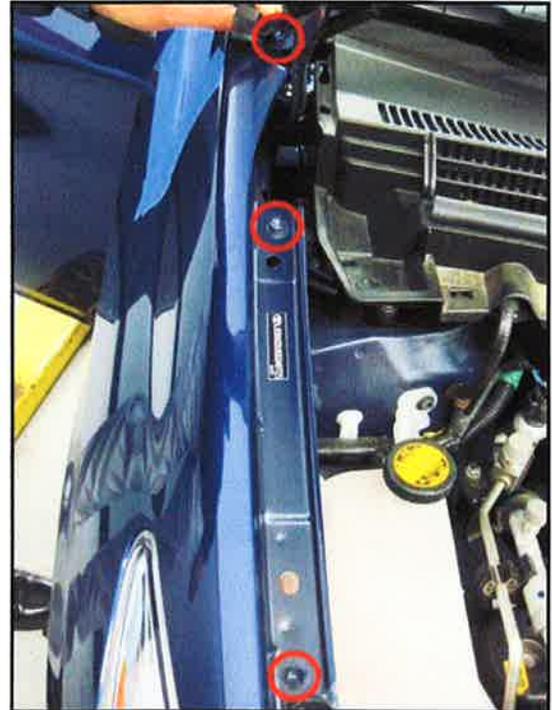
Figure 10.

B. Install the 3 bolts.

Torque: 13.5 N*m (1.38 kgf*cm, 10 ft*lbf)
