Abnormal Noise when Brake Pedal Released

Service Category Brake

Section Brake Control/Dynamic Control System **Market** USA

YEAR(S)	MODEL(S)	ADDITIONAL INFORMATION
2010 – 2011	Prius

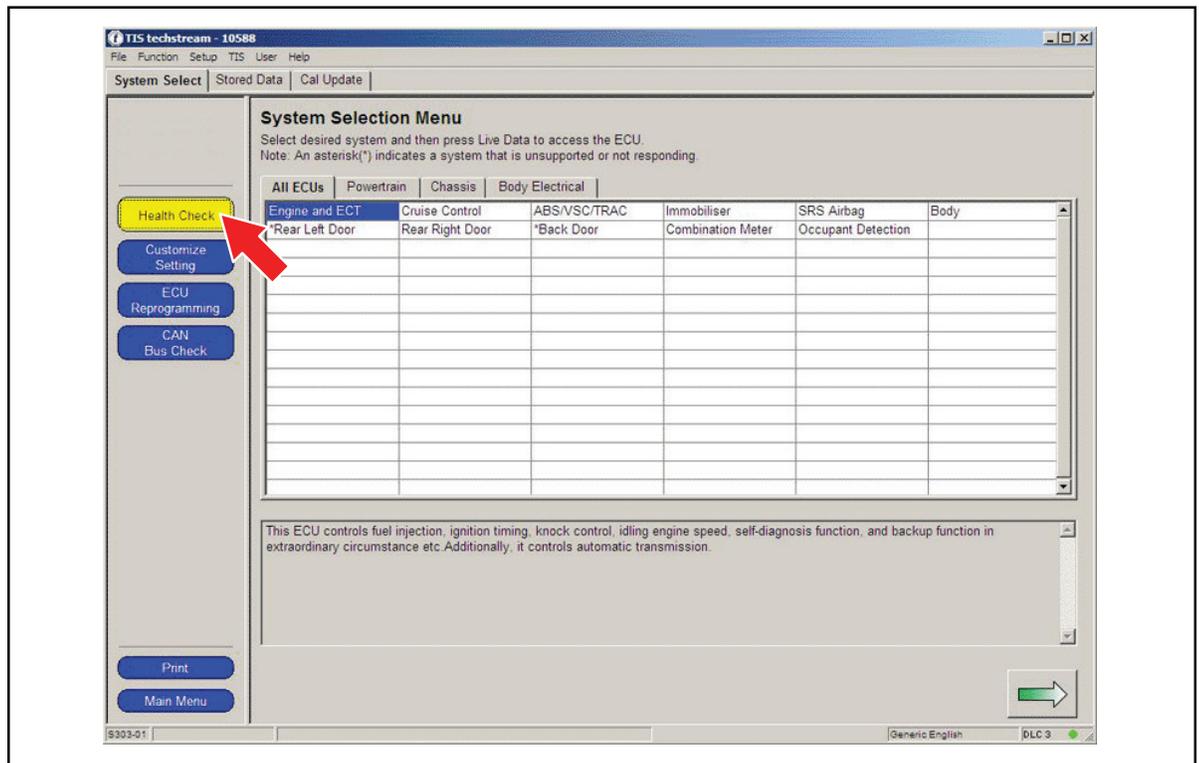
Figure 1.

3. Verify the vehicle’s applicability for recalibration.
 - A. Connect Techstream and establish a vehicle connection.
 - B. Click the *Health Check* button on the *System Select* tab (see Figure 1).

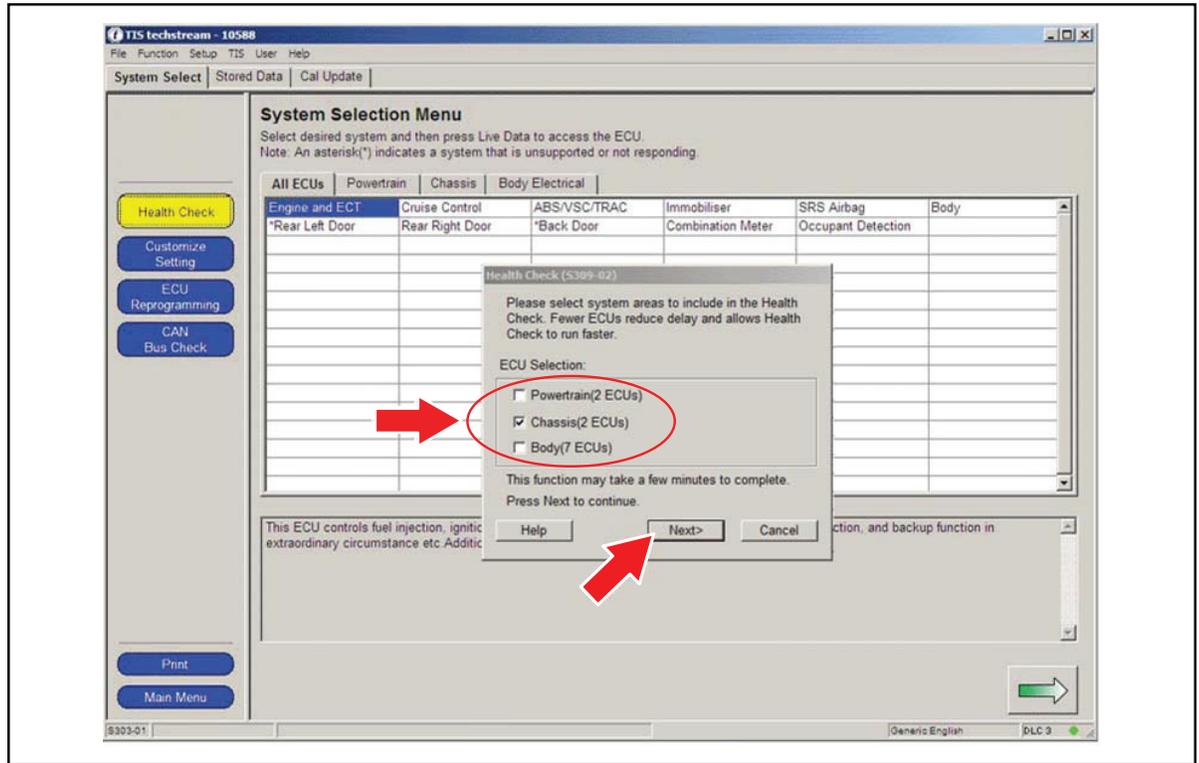
Figure 2.

C. Choose *Chassis* ECU group in the *Health Check* dialog box.

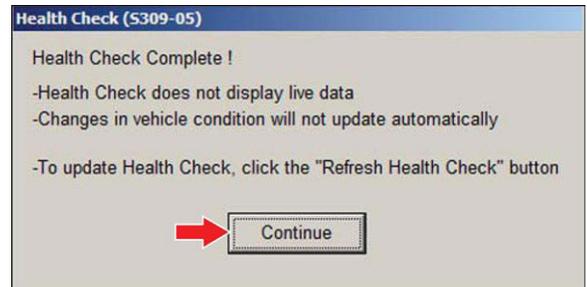
Figure 3.

D. Click *Next*.

E. Click *Continue* to view *Health Check* results.
