SHIFT CONTROL ACTUATOR ASSY REPLACEMENT

2200W-01

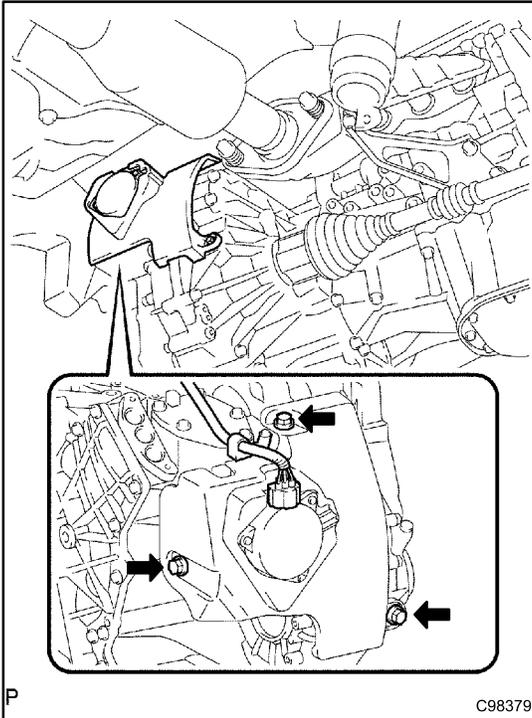
1. REMOVE SHIFT CONTROL ACTUATOR ASSY

- (a) Disconnect the connector.
- (b) Remove the 3 bolts. Remove the transmission case cover from the hybrid vehicle transaxle.

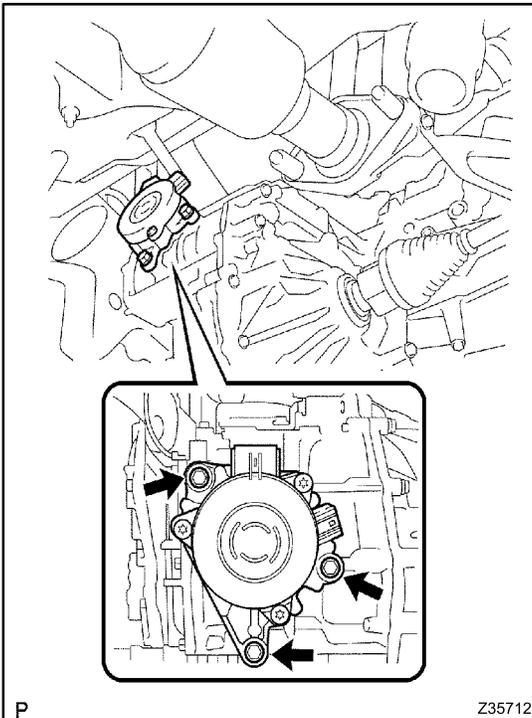
- (c) Remove the 3 bolts. Remove the shift control actuator assy from the hybrid vehicle transaxle.
