HV Battery Cooling Fan Maintenance for Severe Usage Vehicles

Section Hybrid/Battery Control System

| YEAR(S) | MODEL(S) | ADDITIONAL INFORMATION |
|---|---|---|
| 2010 – 2012 | Prius | |

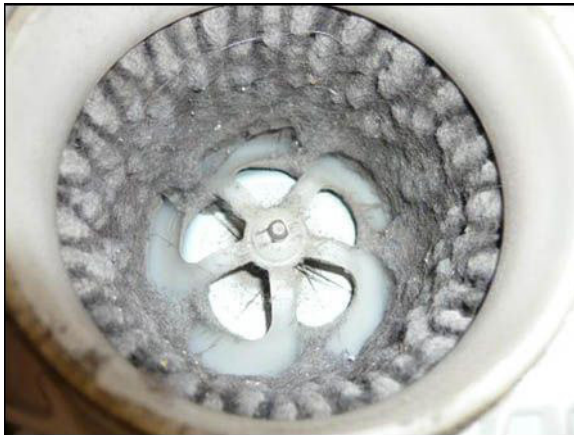
For vehicles that are used under certain severe operating conditions, the HV Battery Cooling Fan may experience an excessive buildup of dust, lint, or other debris that can reduce the efficiency of the HV Battery Cooling System. HV Battery Cooling Fan maintenance and cleaning should be performed to address this condition.

Figure 1. HV Battery Cooling Fan BEFORE Cleaning

- [2010](#) / [2011](#) / [2012](#) Prius:
Engine/Hybrid System – Hybrid/Battery Control System – “Hybrid/Battery Control: Battery Blower: Removal”
3. Using compressed air, clean any dust, lint, or debris buildup from the HV Battery Cooling Fan blades. At this time, secure the fan blades to prevent turning while cleaning.

- Do NOT attempt to clean the HV Battery Cooling Fan while it is installed in the vehicle. Doing so may cause dust or debris to enter the HV Battery Case.
- Failure to secure the fan blades while cleaning can result in electronic circuit failure due to overturning.

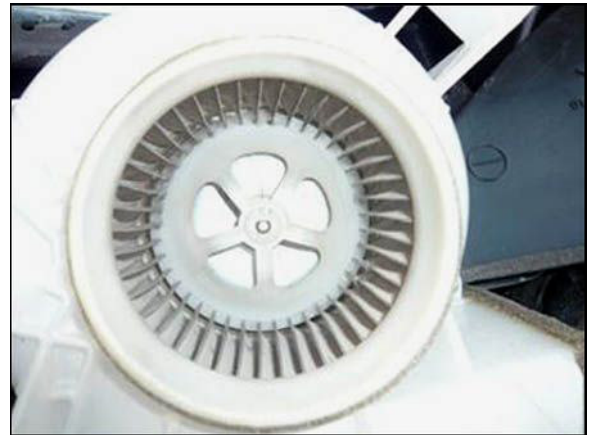
Figure 2. HV Battery Cooling Fan AFTER Cleaning
